# Penn Yan Municipal Board Special Meeting Minutes

March 28, 2019

## Wastewater Operations December 2018

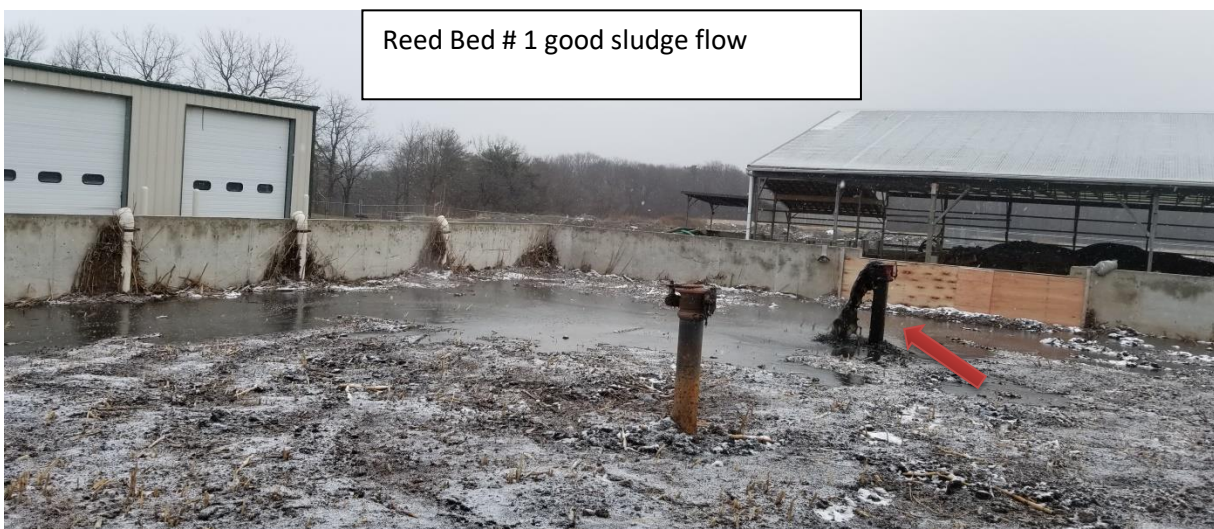
**Reed Beds:** Bed #1 was utilized briefly to pour digested sludge into while trying to identify the reason for inconsistent sludge feed to the press. It was suspected there might be a possible pipe blockage between the Anaerobic Digester and the Press Bldg.

**Press Sludge:** Dewatering Operation was plagued with sludge feed issues during the latter half of the month. The sludge line from Digester #2 to the sludge mix pump in the press building was flushed forwards and backwards. A small amount of sludge was directed to the reed bed #1 to visually see the flow, as previously reported. A thorough flushing of all plumbing, piping, and pumps revealed plastic debris that, once in the wastewater treatment plant does not break down, can cause problems with pumps and plugging.

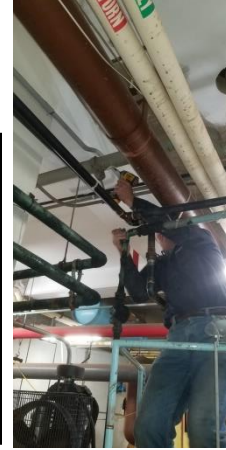
Status light Bar

Digester Valve  
Open Status  
Indicator  
light

Conduit  
runs  
difficult  
install  
among the  
many pipes

**Basement conduit installation:** The Digester valve position light indicator was modified from temporary to permanent. Electrical conduit and wires were run from basement valve housing to the main lobby status light bar. Further work needs to be done with regards to providing source power to the actuator and termination hookups once the actuator is installed.
