AN INHERITANCE OF TIME

Guidelines for the
Village of Penn Yan's
Historic Preservation District

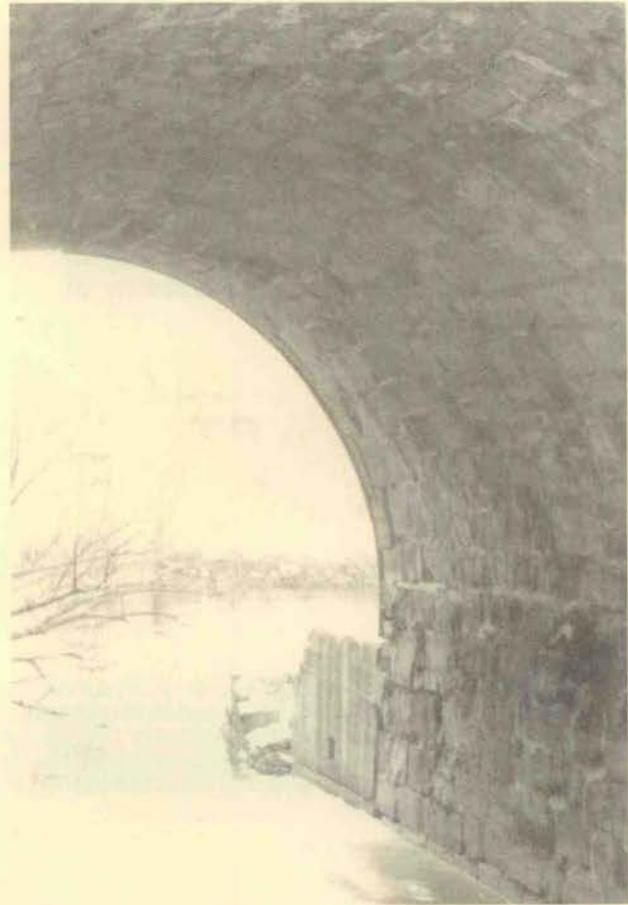
Above: One of the barrel vaults of the Main Street bridge over Keuka Lake Outlet, built in 1884 from limestone blocks used originally in 1848, when the wooden chambers of the Crooked Lake Canal's locks were converted to stone. It took the concerted efforts of many citizens and groups interested in historic preservation to prevent this landmark from being demolished and replaced with a new steel and concrete structure. The bridge's proximity to an Historic District listed on the National Register of Historic Places, its designation by the village as a local historic landmark, its location in a public park improved with local and state funds, its architectural distinction and its strong identification with Penn Yan and its history were all powerful factors used by those who were trying to save it.

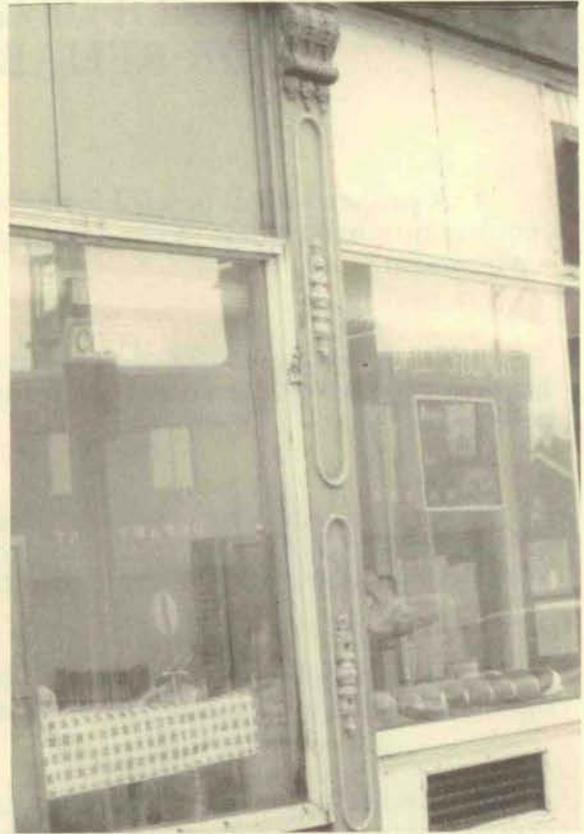
Above: One of the cast iron columns that remain from the original storefronts of 108-110 Elm Street. Historic details like these, dating a fine 1880 commercial block, are what make the village's Preservation District a viable and cohesive entity.

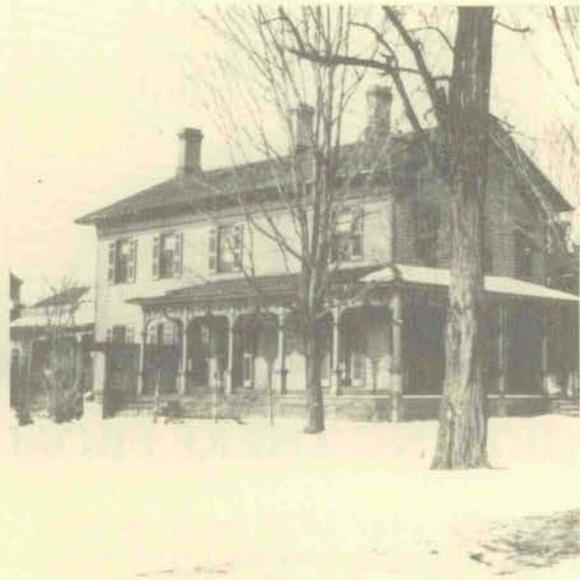
Above: The house built by Andrew Oliver around 1820, later owned by the Hon. John L. Lewis. It was much altered in the 1860s, but the simple rectangular front-gabled design with three interior chimneys is original. This house occupied until about 1900 a lot where 202 and 204 Main Street stand now.

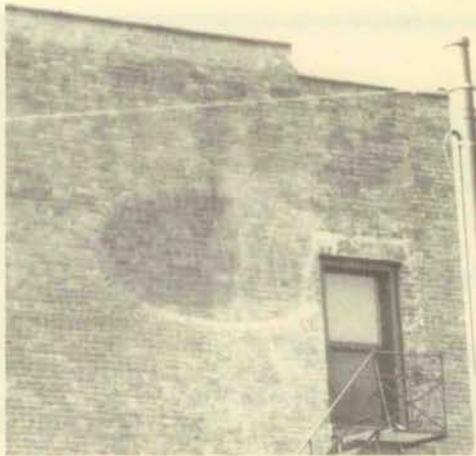
The "ghost" of a Federal-era elliptical window in the end wall of 101 Main Street. This is the site of a store built by George Shearman early in the 19th century and destroyed along with much of the rest of the block by a fire in the early 1850s. Evidently at least this end wall remained to be used when the structure was rebuilt.

structures are clad with wooden clapboards; brick buildings from the Federal period may have an elliptical louver in the end wall, a parapet or step gable, or some other distinctive detail.

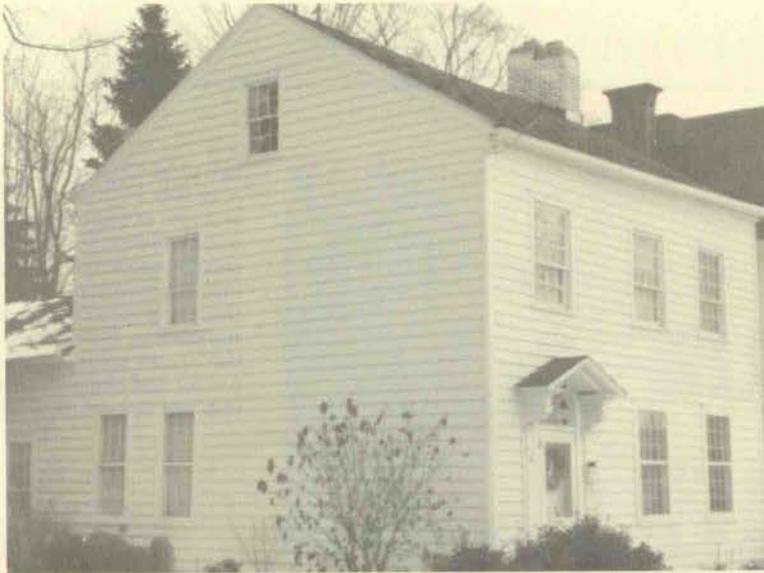
Above: 333 Main Street, whose simple massing, near-symmetrical facade, small-paned original windows and clapboarded exterior proclaim it to be a relatively early house. The small portico over the front door is not original. The transom is rectangular instead of elliptical, and decorated with a web of curved leading. The interior of this house, alleged to be the village's oldest, but which was probably built about 1824 by John Van Pelt Jr., is very rich in Federal detail.

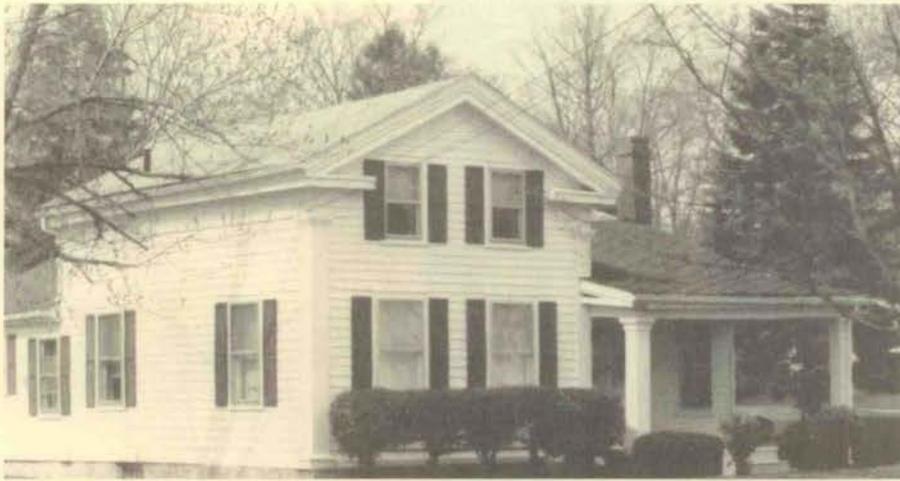
Left: 210 Clinton Street, probably built about 1830 and one of the neighborhood's oldest. Notice the cornerboards with moldings top and bottom so there appear to be pilasters supporting the entablature; the square columns on the porch; and the pediment, reduced to cornice returns.

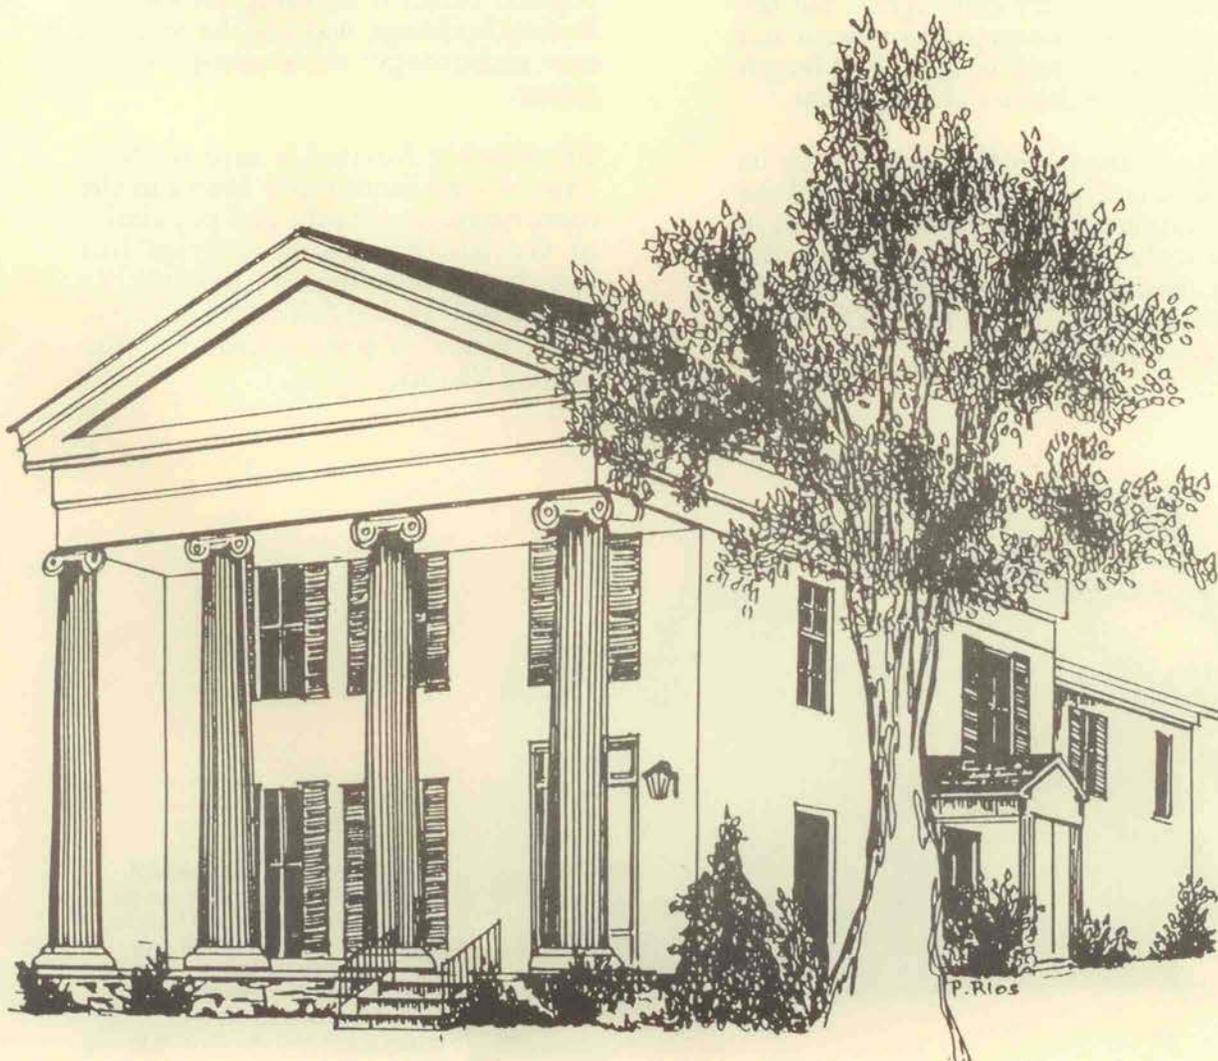
Below: 158 Main Street, built about 1820 when the village was largely mud and tree stumps. Its row of four Ionic columns support an entablature crowned with a pediment. The side porches and west addition were built in the early 20th century. This house with its graceful two-story portico was and remains a village landmark.

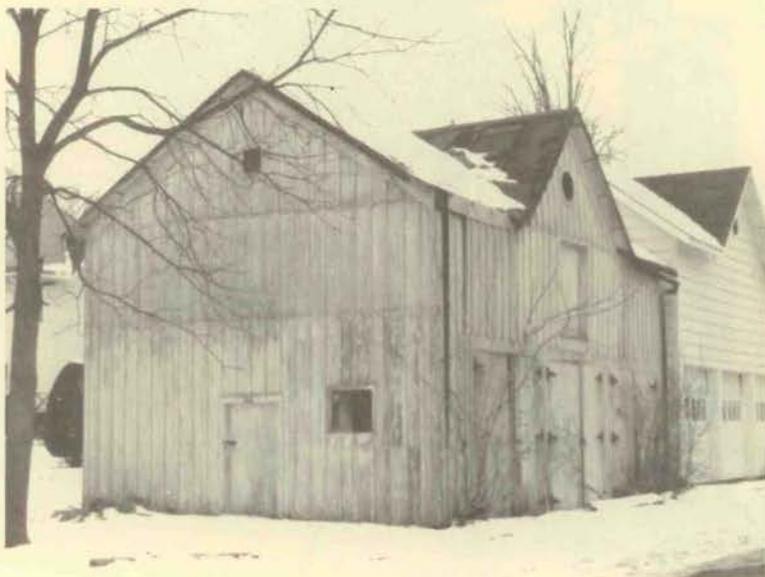
Left: The carriage barn behind 315 Main Street, a good example of how even a utilitarian building might carry out a popular and otherwise elaborate style. This is a rather plain vernacular version of Gothic Revival, denoted by the center gable and the vertical siding.

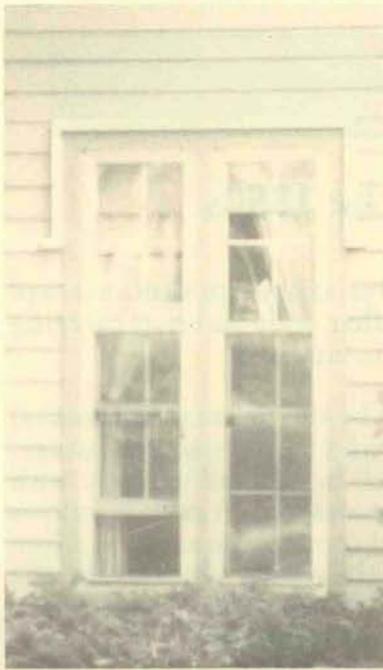
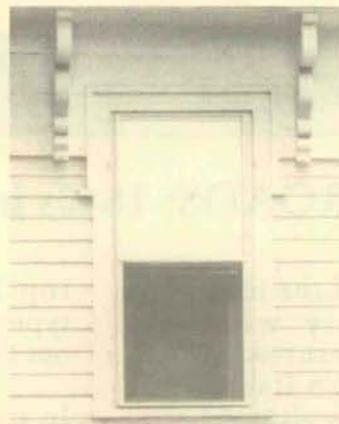
Left: Two examples of a common type of Gothic Revival window molding. A drip molding like this was designed to prevent water from running down the face of the building into the window frame; this shape, horizontal over the top and vertical partway down the sides, is called a label molding. The "ears" at the ends of the vertical pieces are particularly characteristic of the Gothic Revival style. The example at the near left was altered from an original Greek Revival window; the carved brackets on either side are still later Italianate elements.

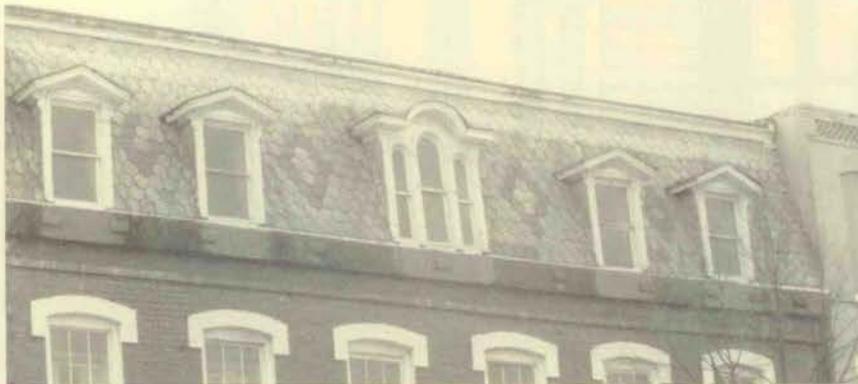
Left: The mansard upper story of 10-12 Main Street, built about 1870, probably by W. H. Watson. The building originally had two storefronts and a decorative iron cresting. The patterned slate roof is original, and with its central palladian dormer flanked by paired pedimented dormers, this would have seemed not only elegant but very modern, a notable addition to its downtown neighborhood.

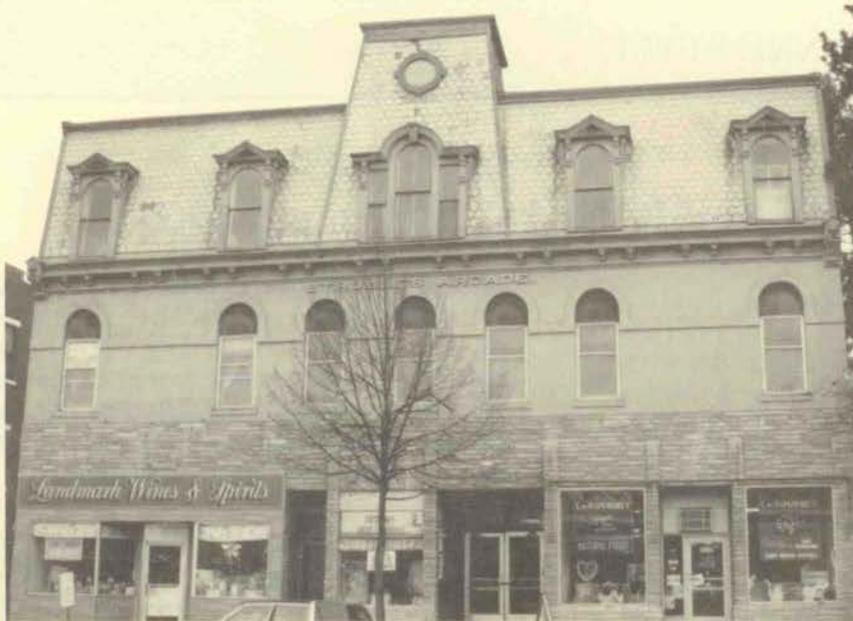
Left: 144-50 Main Street, built in 1869. The building has a mansard roof and a central tower, also with a mansard roof and dormers. The dormers in the main roof are pedimented. The second-story windows originally filled their arched frames and the cornice was repeated below them, complete with brackets and lions' heads. The roof and tower had iron cresting.

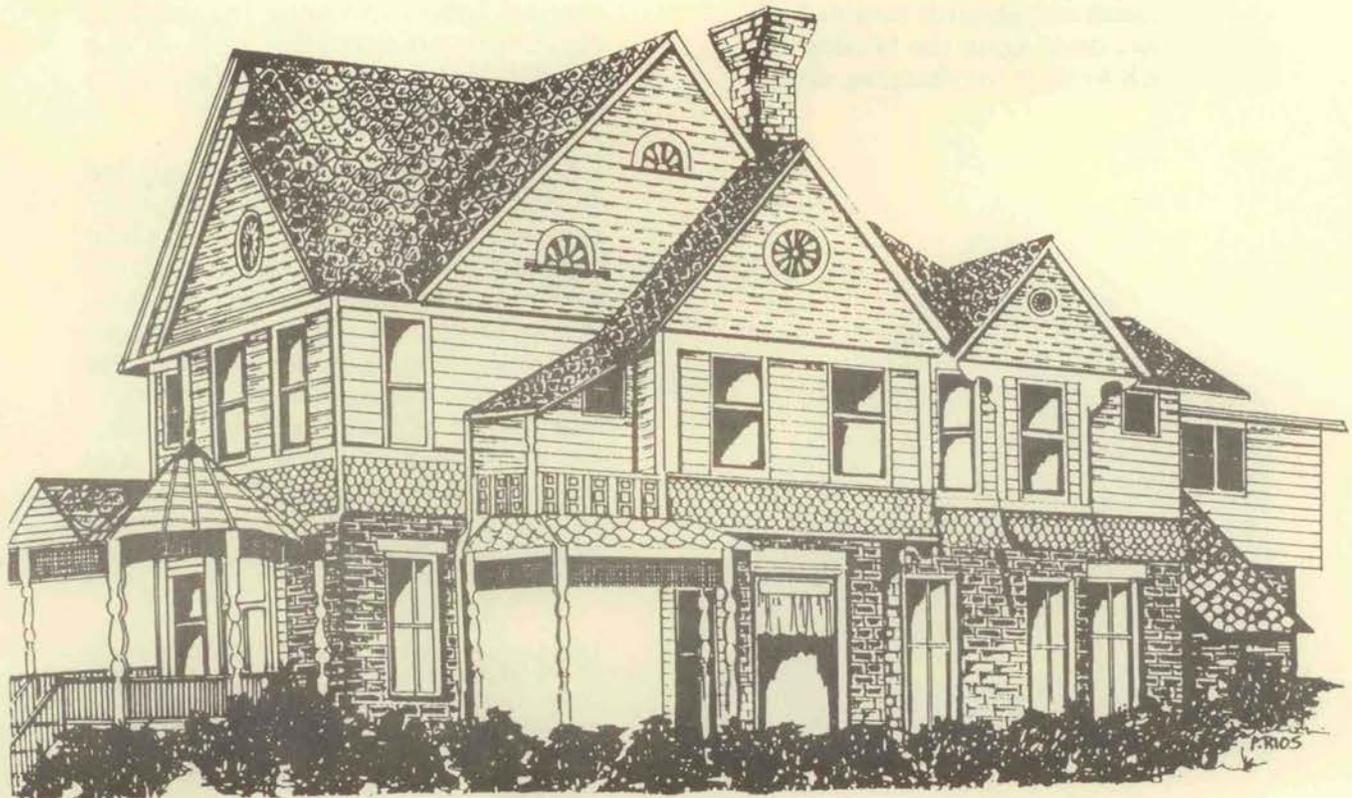
Below: 301 Main Street, built in 1885. Here the irregular massing so popular at the time is very evident. Note also the combination of materials, the decorative shingles, the multiple porches with spindle-work, the round turret hinted at in the porch, the massive chimney, the variety of window shapes and the general exuberance of the design. Every angle of this structure reveals different details.

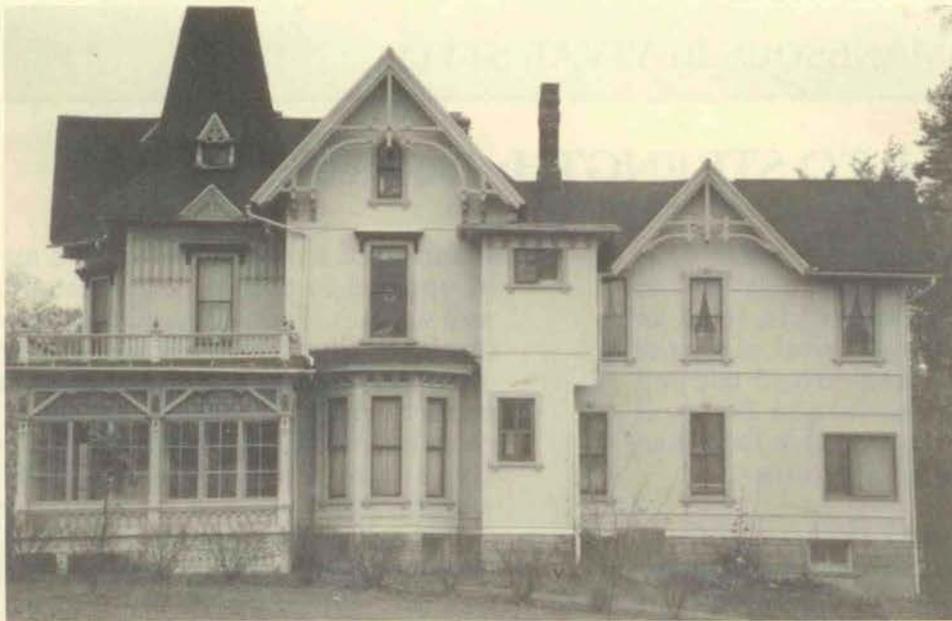
Above: 215 Main Street, built around 1877. This house is eclectic in approach, with a Gothic flavor to much of the detail. The front and cross gables have decorative trusses; subsidiary gables also have trusses, in two other different designs. Note the picket work on the tower, the vertical siding and the stickwork. The porch has chamfered posts and diagonal braces, with spindlework on the balustrade above. The unusual window frames and the applied decoration on the lower porch balustrade add to the wealth of detail on this landmark structure.

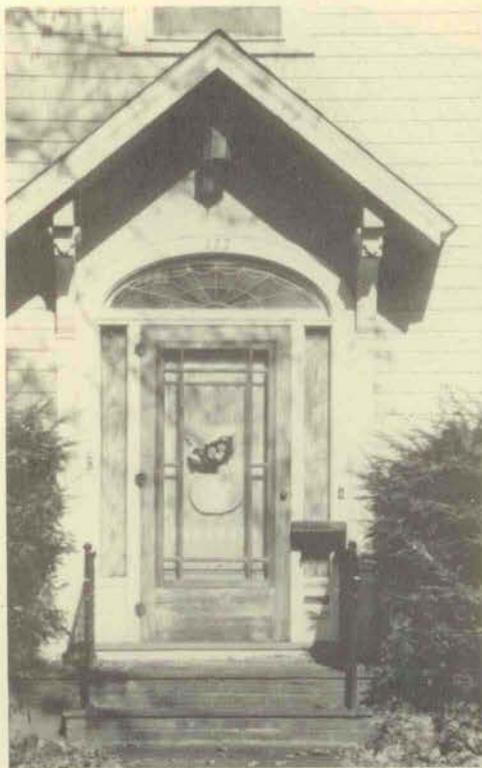
Left: The front entrance to 117 Court Street, a Georgian Revival house built in 1906. The doorway, with its elliptical leaded glass transom and sidelights, imitates the elaborate entrance to a Federal style house of a hundred years before; the pediment is a very free adaptation of a Federal portico, and the simple Japanese-screen design of the muntins of the outer door is strictly 20th-century.

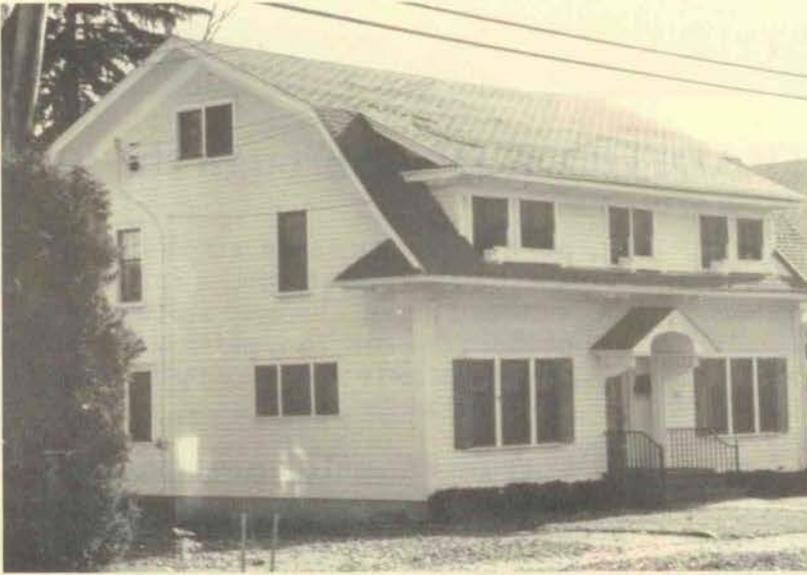
Left: 325 Main Street. This is a 1920 Dutch Colonial house built on the frame of an 1817 Federal structure. The front door, which cannot be seen in this photograph, is probably original with its elliptical transom. The gambrel roof, the shed dormer, the multiple windows and the portico, pedimented but with a curved underside, and the window-boxes are all clues to the 20th-century origin of this house's present appearance.

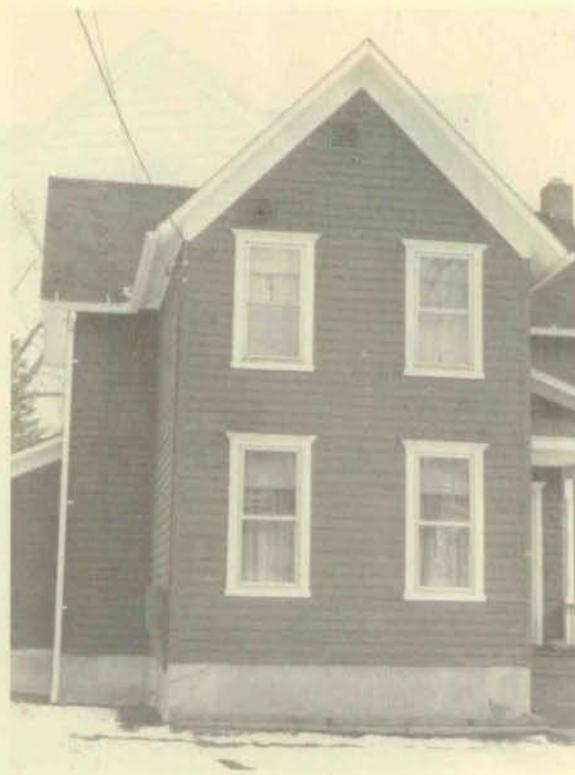
Left: 107 Ogden Street. This is an ell-shaped example with a front-gable entry. The front facade is absolutely symmetrical; note the cornice returns. The porch may be original but its wrought-iron supports are not.

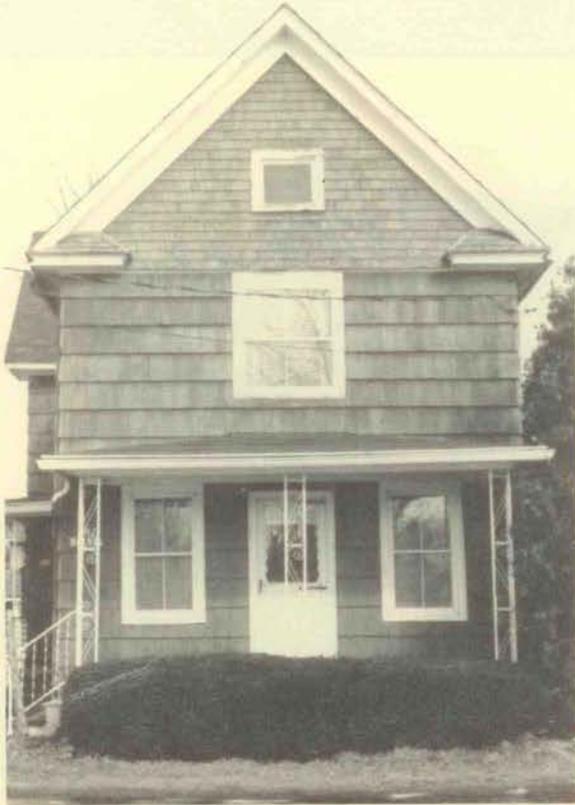
Below: 110 Benham Street. A rectangular example with a front-gable entry; the door is to the left rather than in the center; the restrained decoration of the full-width porch and the shingles in the gable lighten an otherwise rather severely simple facade.

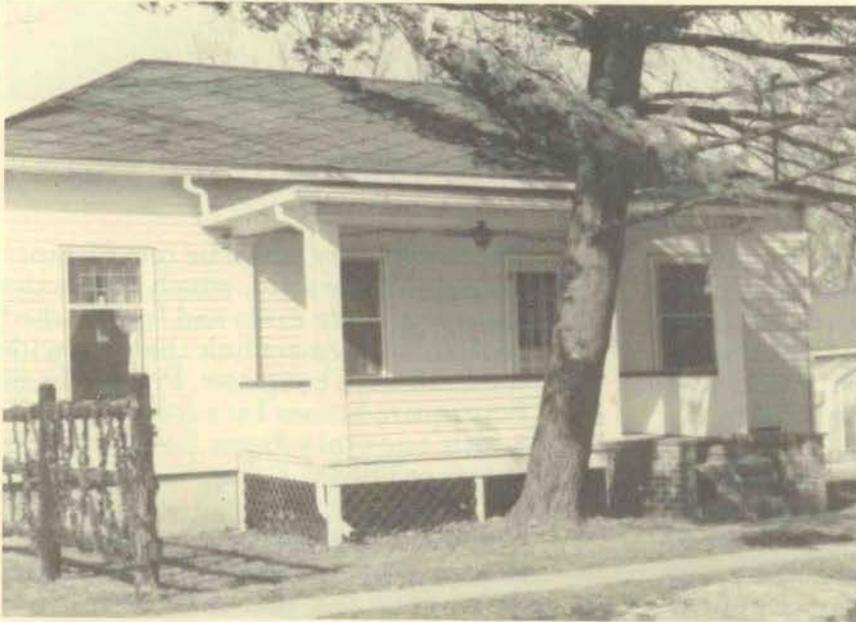
Left: 271 Lake Street, an example of a well-defined vernacular subtype of the Neoclassical house. It is a one-story structure with a hipped roof and a symmetrical columned porch. Note the typical early 20th-century glazing pattern of the windows, small panes above a single large pane.

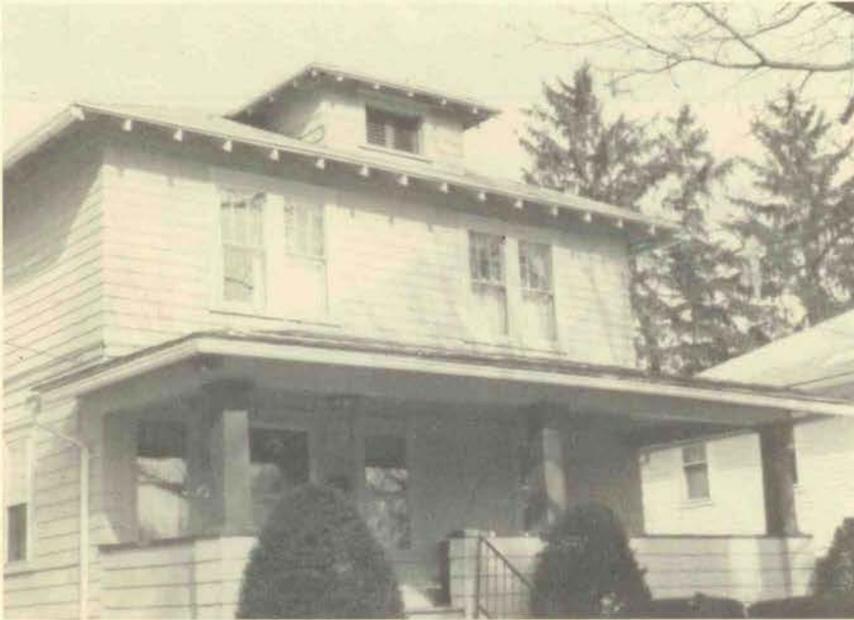
Left: 113 Highland Drive. This house shows the influence of the Craftsman style in the exposed rafters and battered columns of the porch; its shape, centered dormer and full-width porch with filled-in railing are solidly within the Foursquare canon.

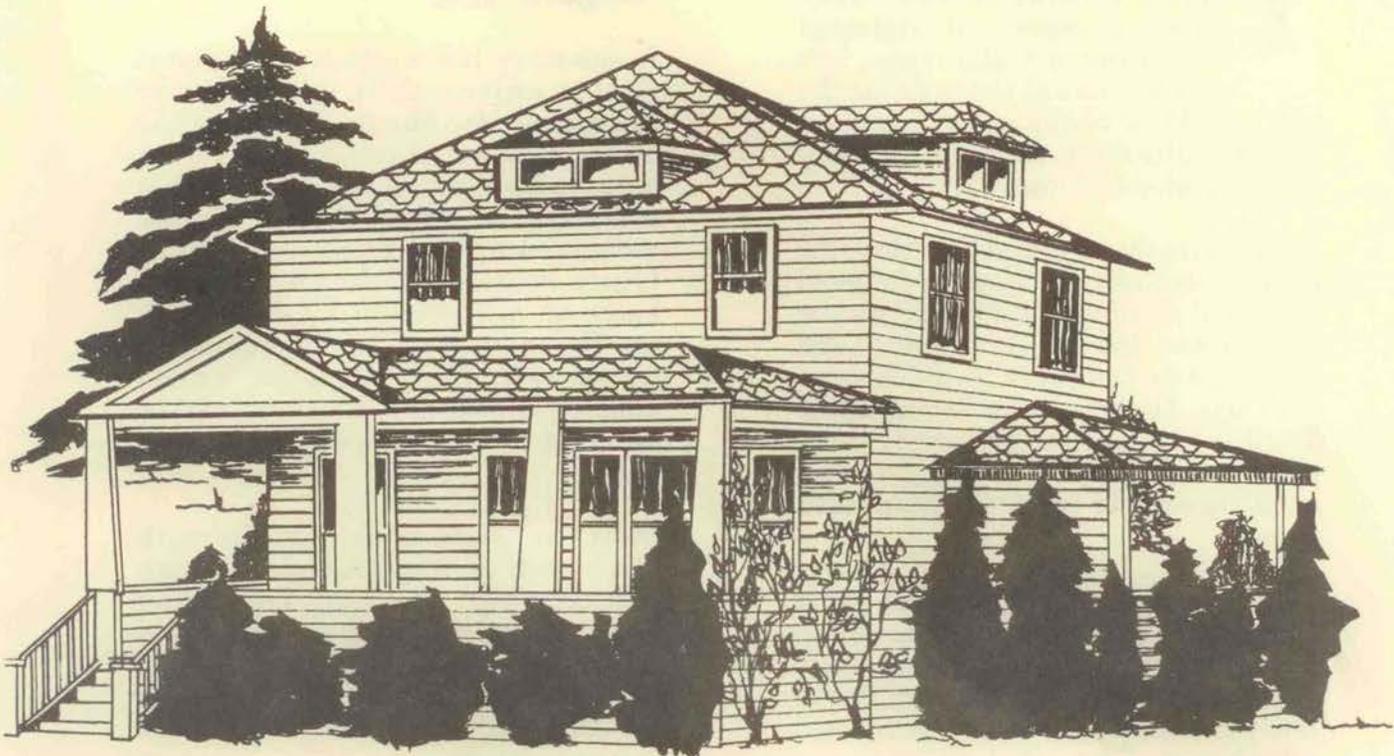
Below: 322 Clinton Street, built in 1914. Every detail of this house repeats the Foursquare themes of simplicity and solidity, from the cubical shape surmounted by its pyramidal roof, the dormers echoing the same roofline, the large windows and full-width porch. The asymmetrically-placed pediment and doorway balanced by the large triple window add individuality to the facade.

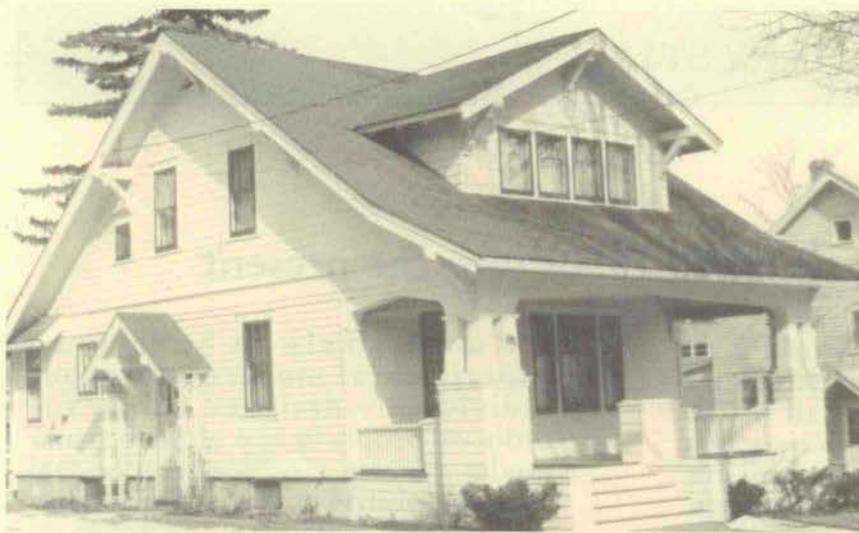
Opposite: 130 Ogden Street. This house has a more steeply-pitched roof than many, and a wide shed dormer making more room than usual on the second floor. Typical Craftsman details include the integrated porch with its battered full-height columns and the exposed rafter ends on the main porch, dormer and side bay.

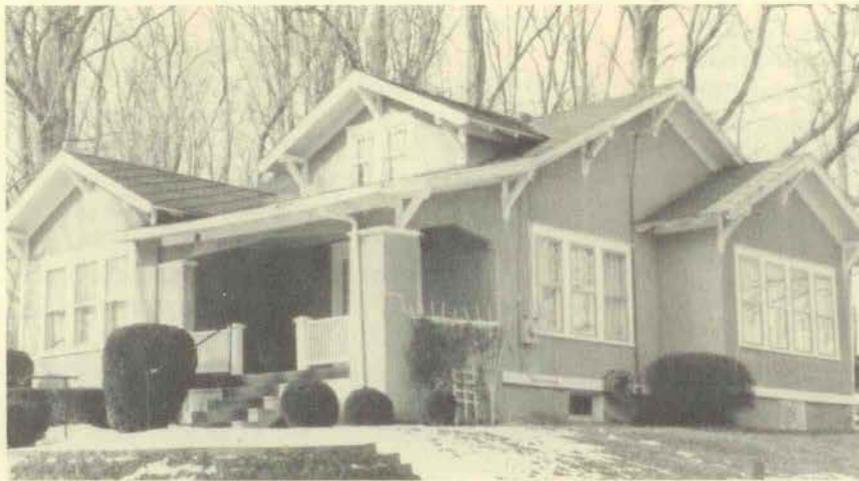
Upper left: 235 East Main Street. This house has a front-gabled dormer with ribbon windows. Note also the battered colonettes on pedestals supporting the porch and the braces under the eaves of the gables.

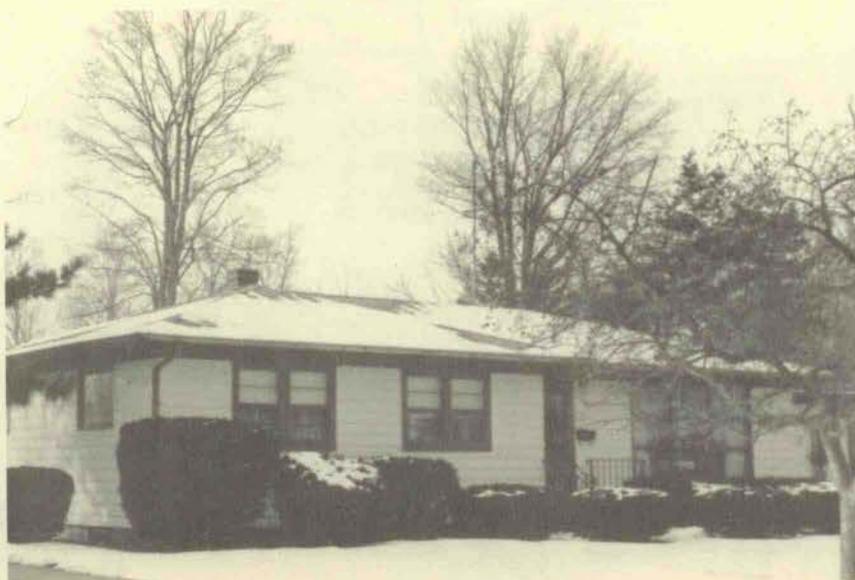
Left: 3 Crescent Drive, a Ranch style house with a hipped roof and double front windows balancing the large picture window. Large expanses of glass like this are appropriate to post-World War II homes but not to earlier ones.

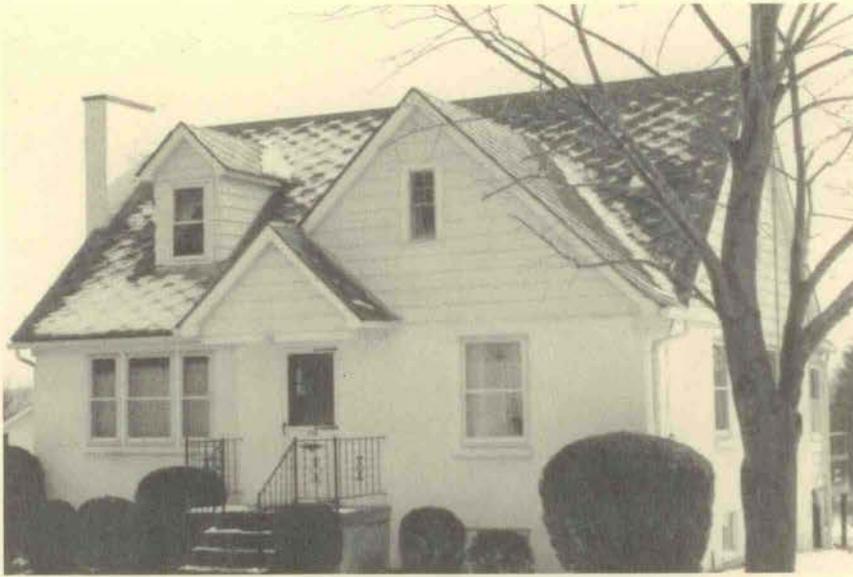
Left: 114 Keuka Street, a Cape Cod style house modified with an asymmetrical front gable; its shape is repeated in the portico and dormer. Many contemporary houses retain some traditional stylistic details, as this one has.

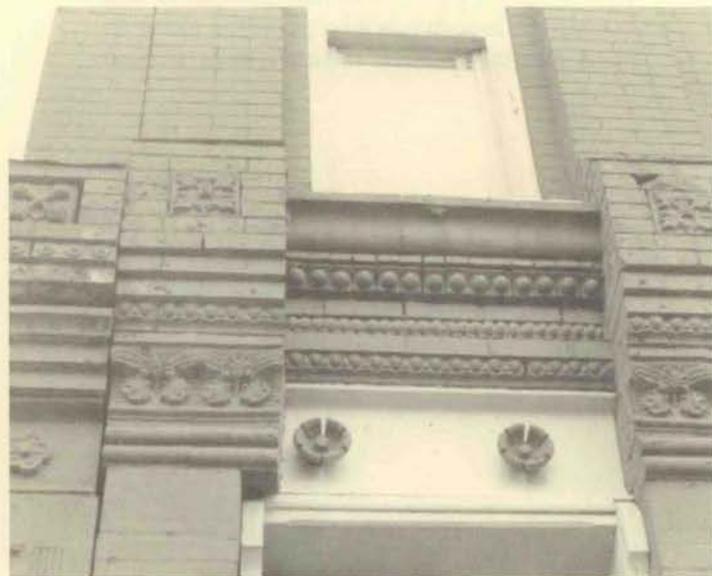
Right: Use of a variety of materials in a commercial structure at 131 Main Street. This store was erected in 1889, designed by Charles V. Bush, a local builder whose talent is stamped on many of Penn Yan's nineteenth-century commercial buildings. Brick, wood, cast iron, stone and terra cotta all contribute to the fabulously intricate interplay of elements in this facade.

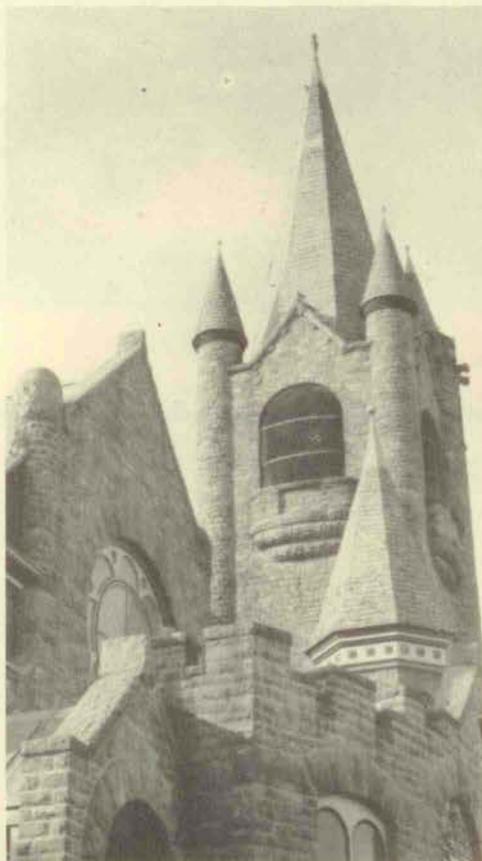
Very few buildings in Penn Yan are made entirely of stone. This is one of them, the church at 168 Main Street, built in 1896 of red Medina sandstone by the Methodist Episcopal congregation. The style is Romanesque Revival, the model a medieval fortress, down to its round arches and castellations, perhaps to dramatize the idea of the Church Militant. The general heaviness of the design is considerably lightened by the multiple spires and multicolored wooden trim. The stained glass windows are particularly large and spectacularly beautiful. The original church on this site was a wooden one, built after the local Presbyterian congregation split over the issue of the abolition of slavery; by 1857, when the Methodists bought the building, the issue was no longer much debated locally and the Presbyterian congregation had reunited.

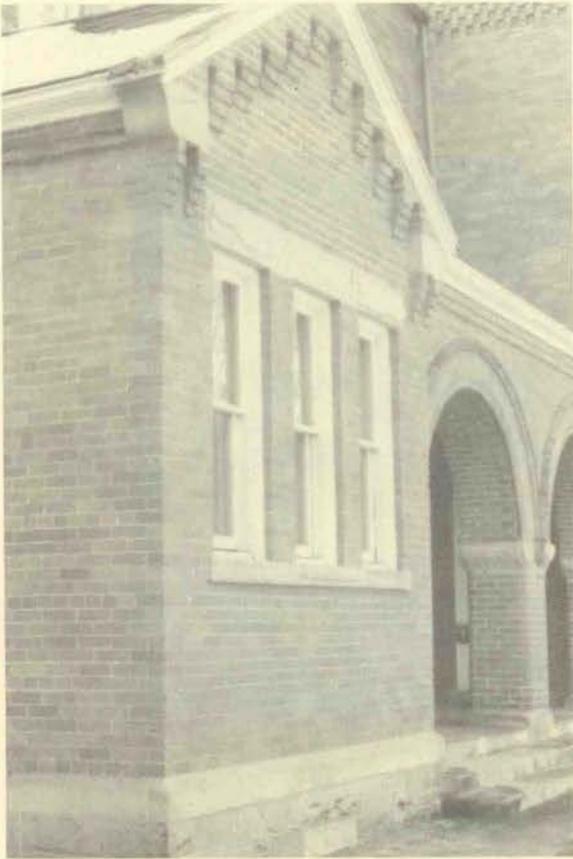
Left: Brick and stone together make a statement of solidity and strength. When this structure at 226 Main Street was built to house the Yates County clerk and surrogate court, it replaced a much smaller Greek Revival building that to most contemporaries seemed mean and rustic. Restrained decorative devices like the corbelled cornice line and the patterned brick on the tower lighten the dignified and simple facade.

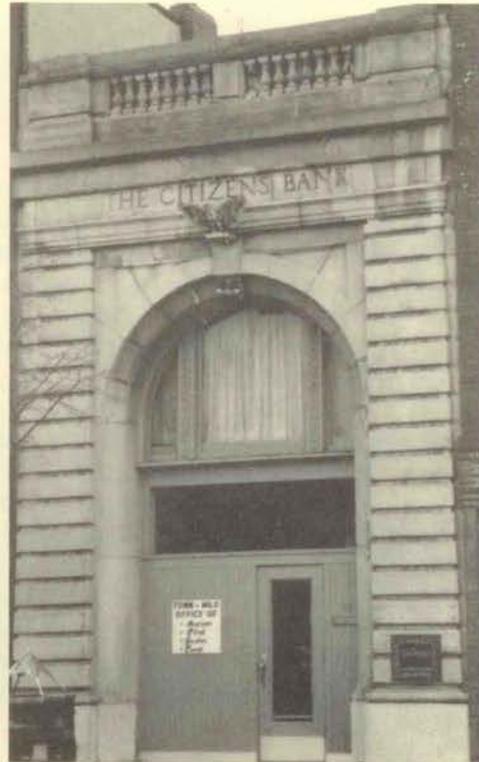
All three pictures on these pages illustrate masonry buildings. Each has unique features that will demand special attention to maintenance during the course of time. Right: 140 Main Street, built in the Italianate style in 1873, with a facade that was completely changed in 1911. The stone and concrete front and balustrade have needs that are quite different than the brick facades on either side. Opposite: 121-123 Main Street, another old structure with a remodeled facade. The brick pilasters, stone lintels and terra cotta panel all help define the character of this building and would be extremely difficult to replace if damaged.

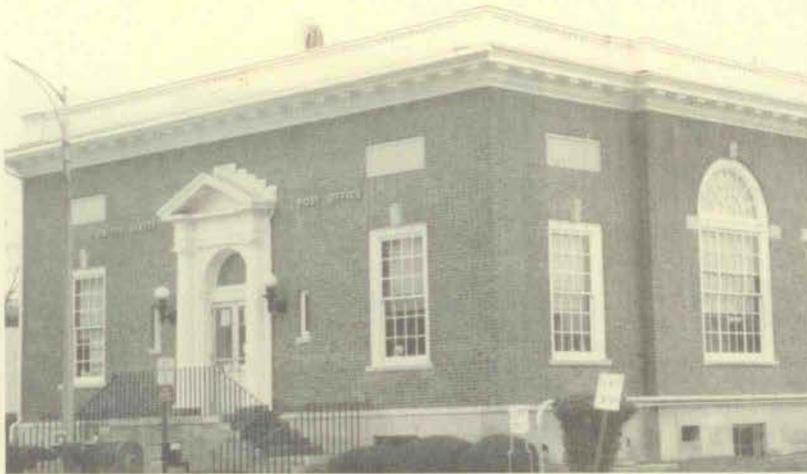
Left: 157-161 Main Street, the village's Post Office, built in 1912, designed by John Knox Taylor at the end of his career as United States Supervising Architect. He handled traditional forms with sympathy and skill, and this solid brick structure is no exception. The brick is laid in a pattern called Flemish bond, alternating the long and short faces of the bricks. A belt course of bricks standing vertically on edge runs at the level of the windowsills, and the arches and keystone lintels over the windows are also outlined in bricks laid edgewise.

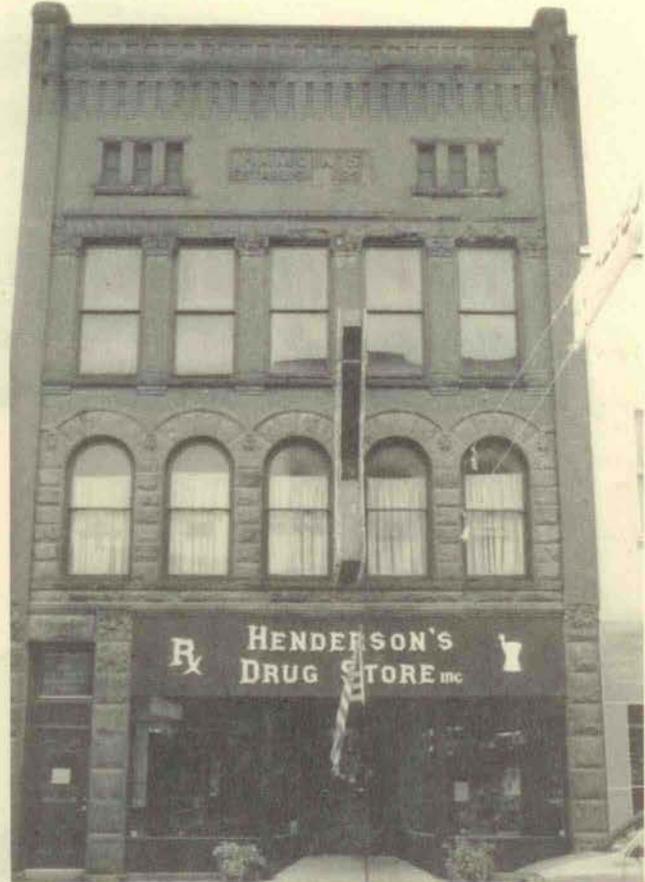
Above: 126 Main Street. Until the 1880s this store had a simple brick Greek Revival front. The facade was modernized with Medina sandstone in a Romanesque Revival style, with rounded arches, windows set in bands and a new fourth story. The rock-faced blocks of stone yield an imposing facade, speaking of strength and solidity.

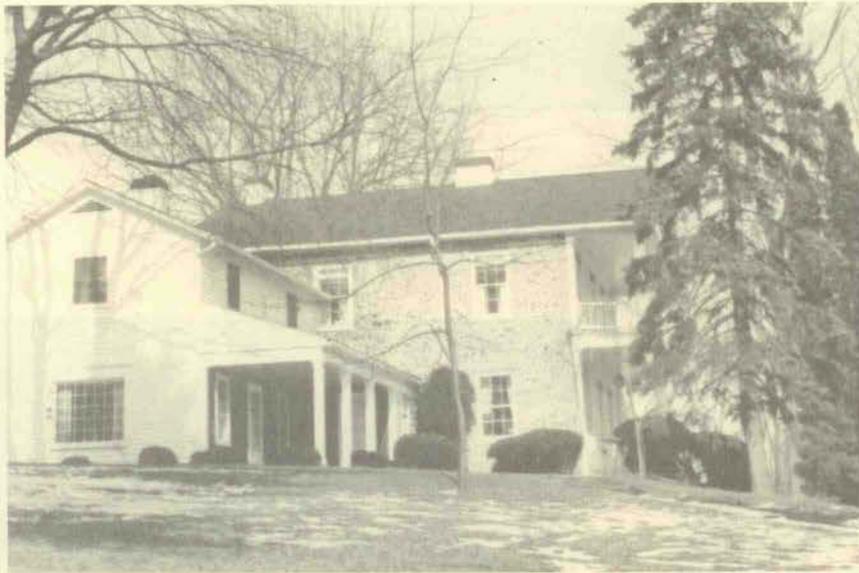
Some residential examples of stone masonry. Left: 107 Highland Drive, one of two stone houses in the village, built about 1820 by Roderick Morrison of Virginia. This is the house in which village founder Abraham Wagener died in 1858. Unlike the Sheppard house on Main Street, this one is not constructed of stone blocks, but of unshaped stone held in place by an application of mortar. Its walls are tremendously thick. The lintels are single blocks, and the front facade finished smoothly and painted.

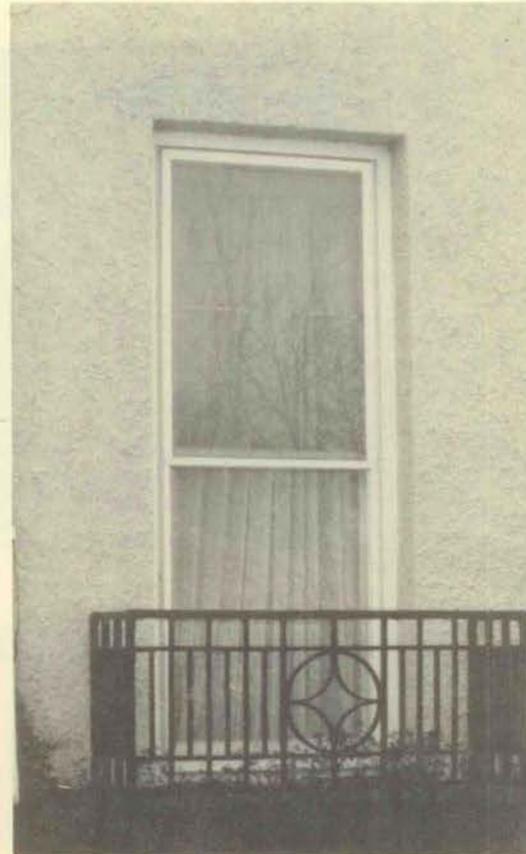
Above: One of the windows in the pale gray stucco facade of 166 Main Street. Notice the iron balustrade, which, like the stucco, is the result of the 1911 make-over of this building. The effect here is of dignity and monumentality.

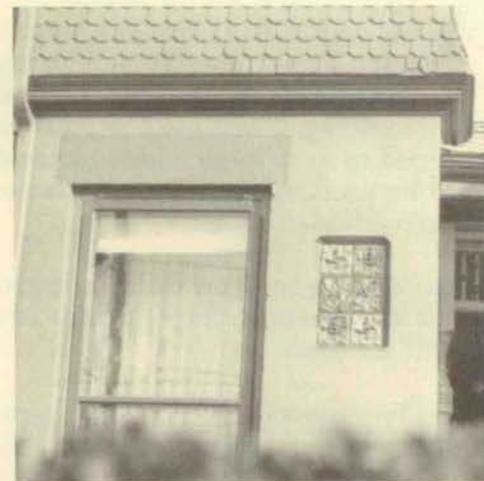
Above: A relatively rare example of residential terra cotta ornament, one of the plaques set into the brick wall of 301 Main Street. This one shows fruit and foliage designs; another a little screech owl, still another the date the house was built.

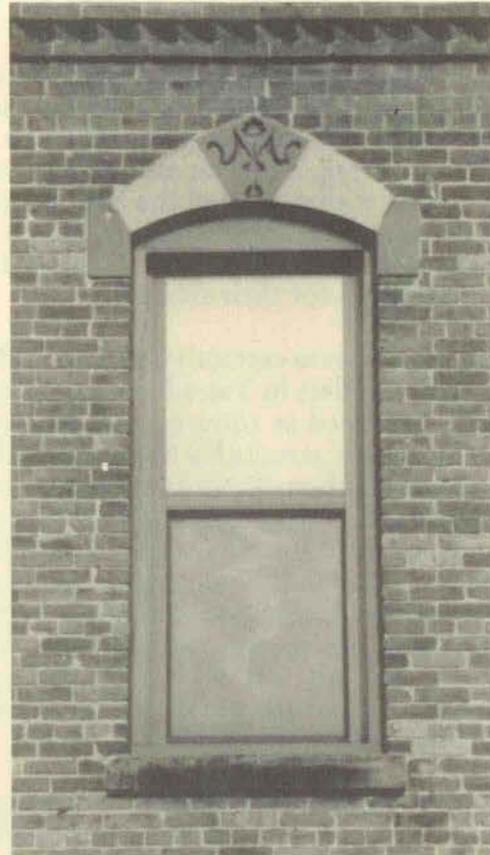
Above: One factor that must be taken into account is that some masonry materials are tougher than others. This window opening in a brick wall has stone and terra cotta components. All must be taken into consideration before a decision is made on a cleaning technique.

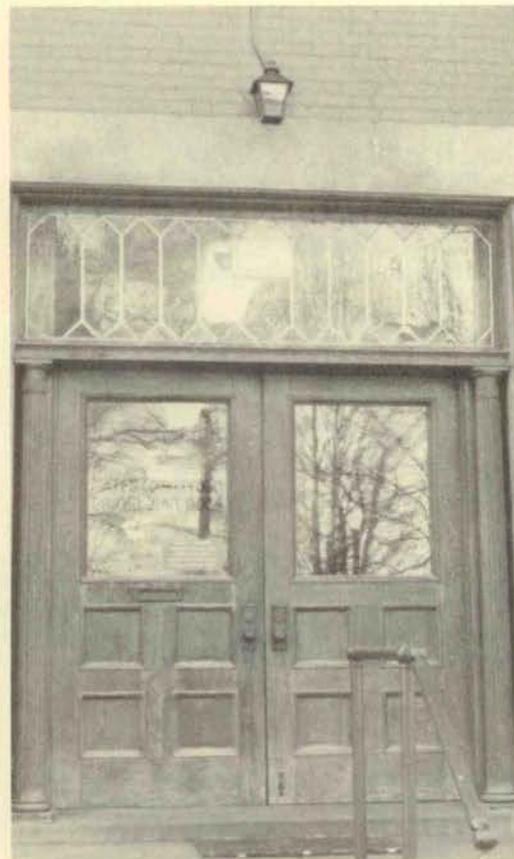
Above: The main entrance to the Yates County Court House, 226 Main Street. The original entryway of this 1835 Greek Revival structure was the same size, a panelled single door with small columns and sidelights. This oak double door with its carved solid oak columns and leaded transom was fitted into the old opening in about 1920. It matches the impressive carved oak interior woodwork and is a significant part of the building's present and mature personality.

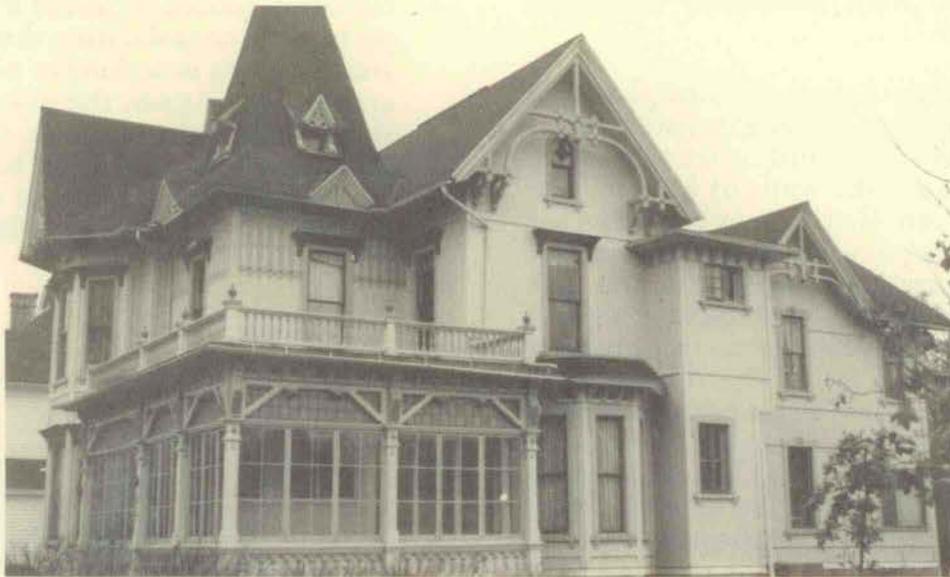
Below: A conspicuous example of vertical siding at 215 Main Street. The boards are laid flush, instead of overlapping as clapboards do. The delicate applied stickwork, picketwork and other characteristic Gothic ornament add to the uniquely rich detail of this house.

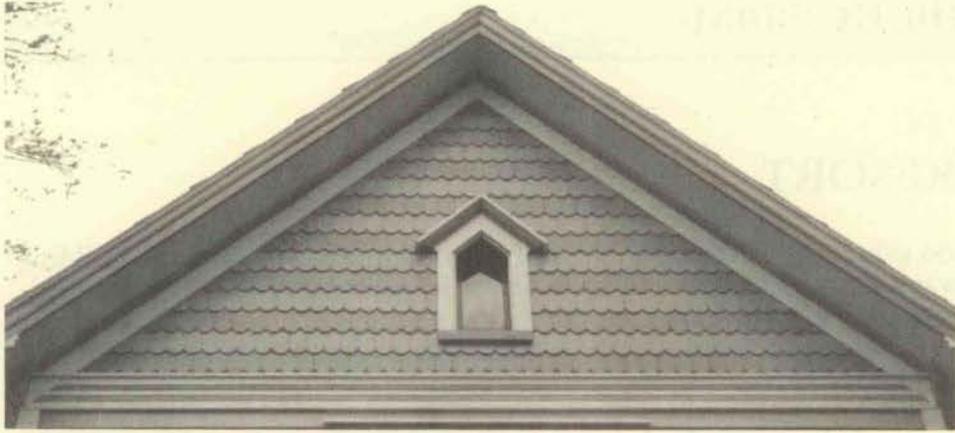
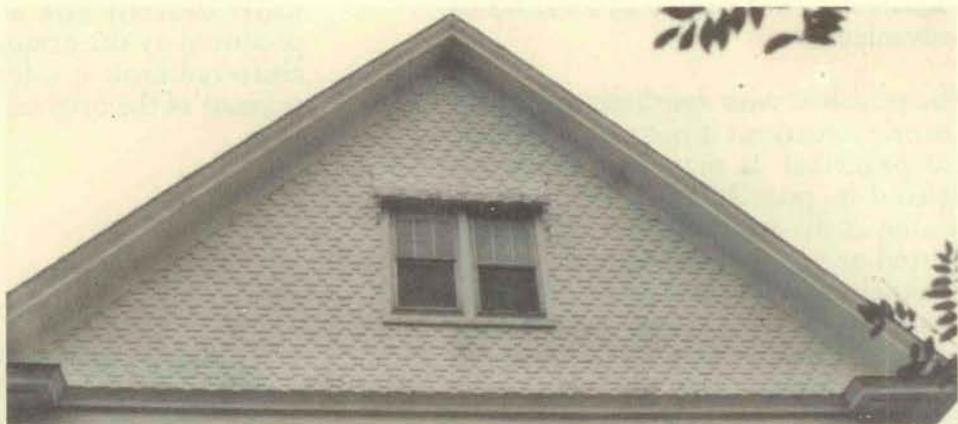
Above: Three examples of shingled gables on clapboarded houses. Each uses a different pattern. Some structures use more than one pattern on different parts of the same wall; this effect was especially popular during the last quarter of the nineteenth century.
