AN INHERITANCE OF TIME

Guidelines for the
Village of Penn Yan's
Historic Preservation District

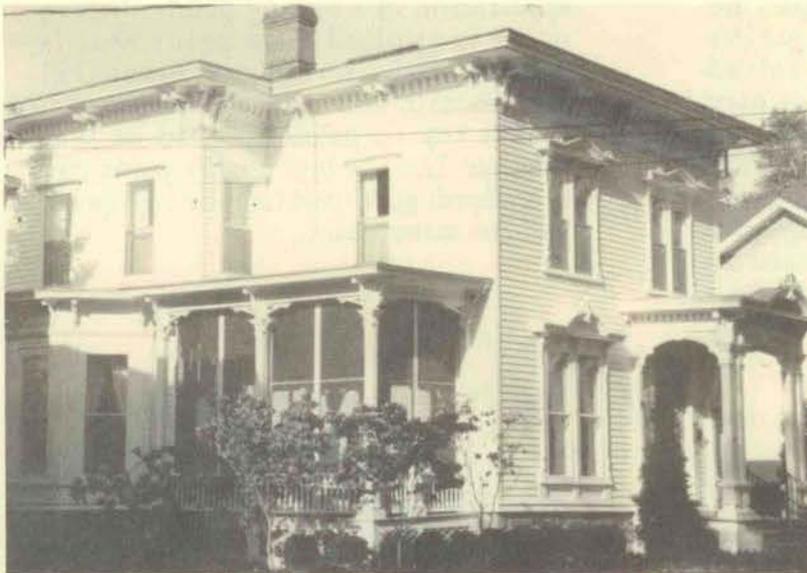
Left: 328 Main Street, built in 1868 in the Italianate style. The narrow clapboards provide a background for the beautiful moldings and trim of this house. Note the very high relief of the window trim on the east facade, and the decorative panel below the first-floor windows. The narrow boards that delineate the corners and sills of the house, together with the wide overhanging cornice and its moldings, are important factors, defining both the Italianate style of the house and its own particular personality within that style.

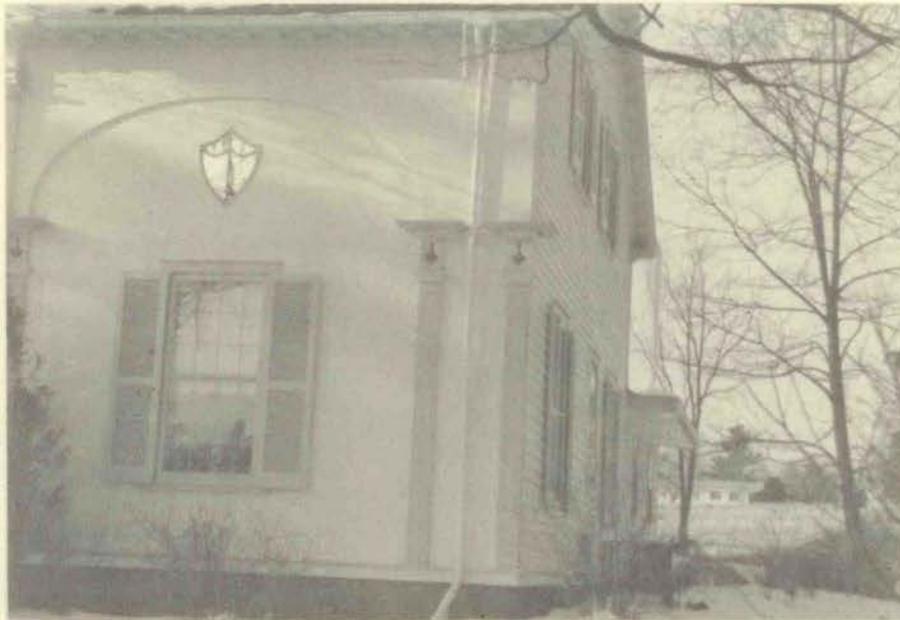
Left: A close look at the very subtle color scheme of 314 Clinton Street. This house was built in 1908, but in 1938 it was remodelled inside and out, and much enlarged, by the architect I. Edgar Hill. The original house was one story with a recessed porch; now it is a very carefully designed Colonial Revival structure based on a Federal house in Troy. The light Federal details are picked out in a tone only slightly darker than the body color, in keeping with the restrained and sophisticated design.

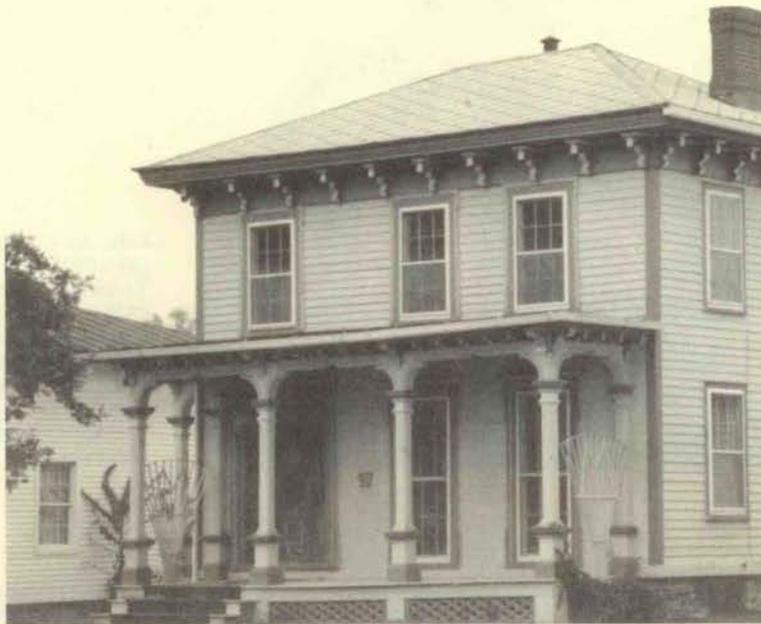
Opposite: An Italianate house at 121 Court Street. The body color is a medium shade of mustard yellow, with the trim in a darker shade of the same color and picked out with a line of dark red. The deep relief of the moldings allows them to speak for themselves in terms of shape rather than color. This is an authentic and attractive color treatment for a house of this period.

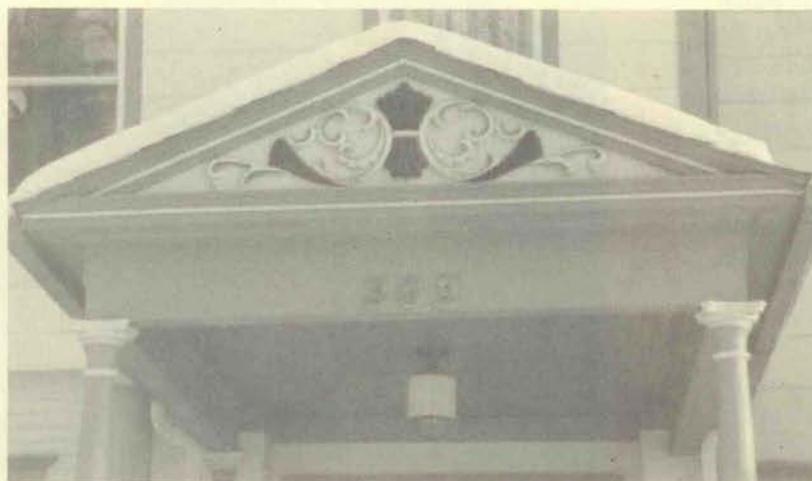
Left: The elaborate trim of Queen Anne houses can present a challenge. This is the front portico of 303 Clinton Street. The main trim color is a darker shade of the body color. The pediment here is the lighter body color, with the carving picked out to accent it.

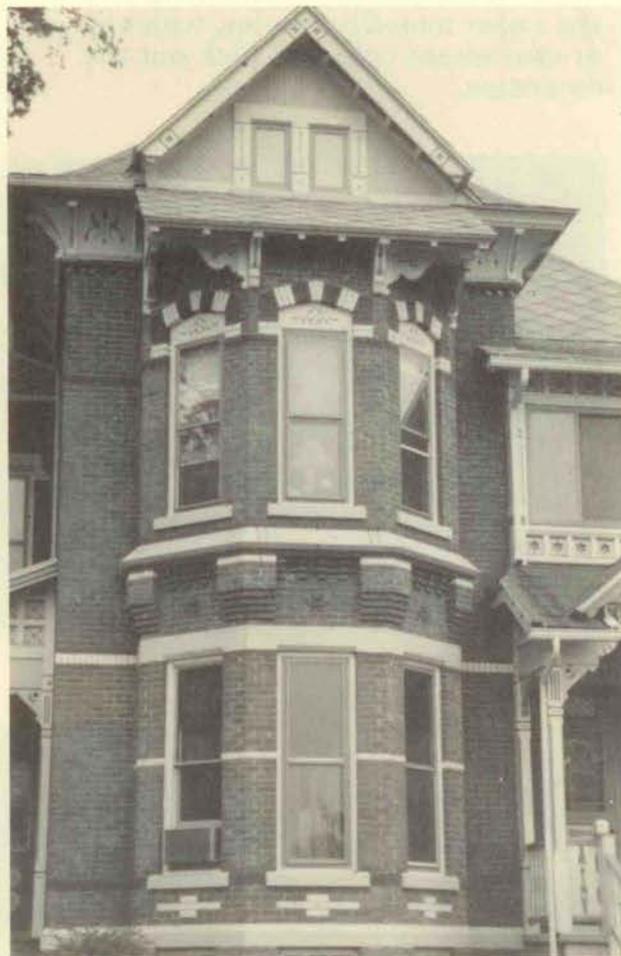
Right: The flamboyant High Victorian styles use the fabric of the house itself as decoration. Sometimes it's fun to accent this with an equally flamboyant color scheme, but it isn't necessary. Here, the colored brick and the cutout designs on the wooden trim provide enough interest that a subtle series of pale colors are all that is needed to pick out the details without tiring the eye.

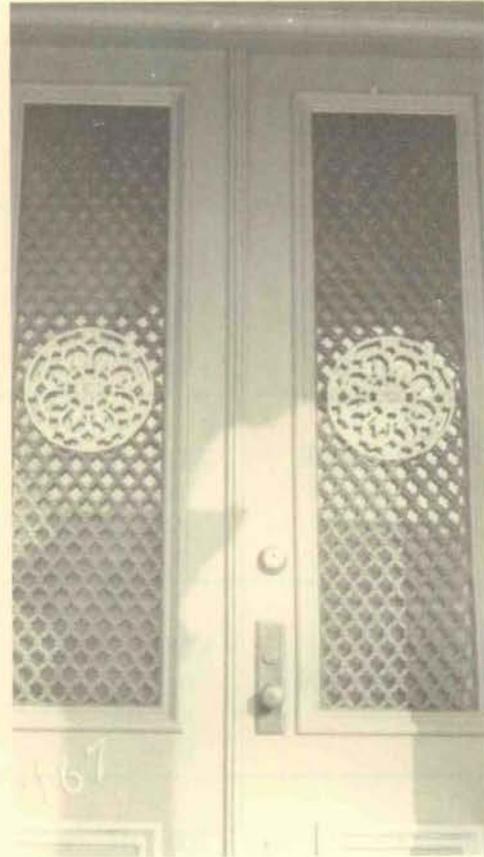
Above: The front door of 167 Main Street, with its metal grill. This is a particularly elegant and well-preserved example of a feature quite popular among local builders of Italianate houses. This house was built about 1848, but the front part with this doorway was added in 1867 by George M. Cramer, who came here from New Jersey to open a clothing store. He evidently wanted his house to reflect his prosperity, and chose to adorn his home with this cast-iron arabesque.

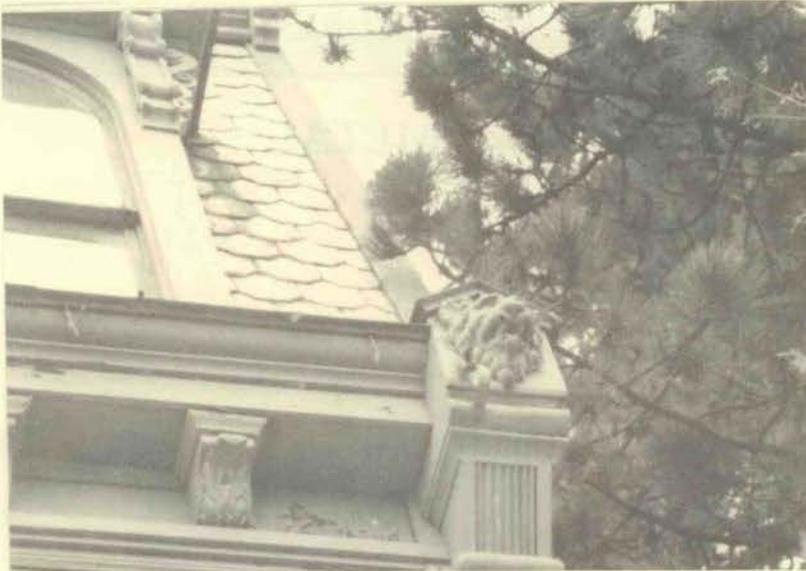
Left: One of the lion-headed brackets on the facade of 144-150 Main Street. The original built-in eavestroughs terminate at each end in these brackets; originally there was another set below the second-story windows. In 1869, when this structure was designed and built, features such as these denoted the importance and commercial success of the owner.

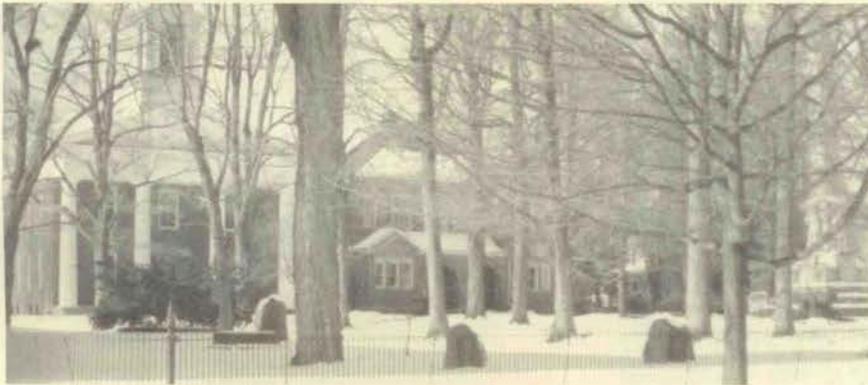
Right: The cupola of the Court House itself, with its metal dome. This was recently refurbished, an unusual example of a metal roof that is not the standing-seam design. The original metal was copper, and may have been gilded; the intent was to have a shiny surface, and this effect was reproduced with stainless steel shingles.

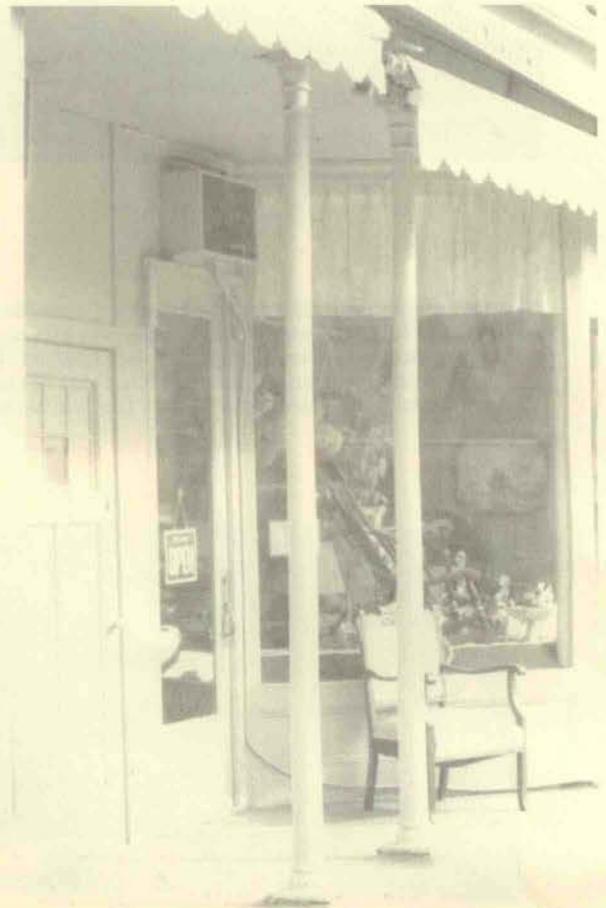
Above: The front entrance of 107-109 Main Street, a single building containing two storefronts. The free-standing cast-iron columns supporting the facade are unique in Penn Yan. They were presumably put in some time early in the 20th century. Like many cast iron architectural features, these are painted to prevent rusting.

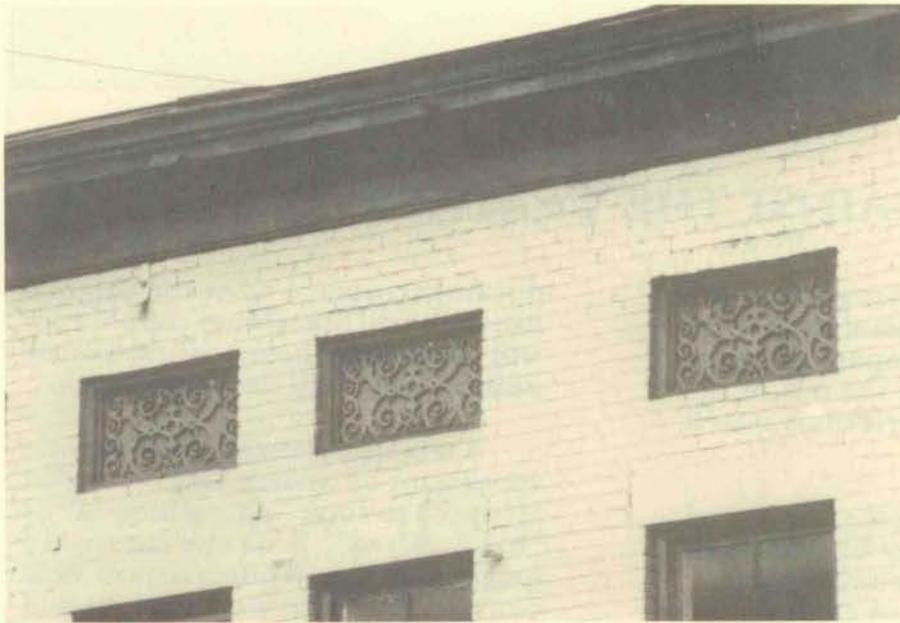
Above: The cornice and eyebrow windows of 107 Main Street. This building and its neighbor at 105 were built in about 1840 and are together the only remaining relatively unaltered Greek Revival commercial block in Penn Yan. The cornice is of wood, and the windows have their original decorative cast iron grills. The decorative arabesque design is the only purely ornamental feature in these simple and rather severe facades.

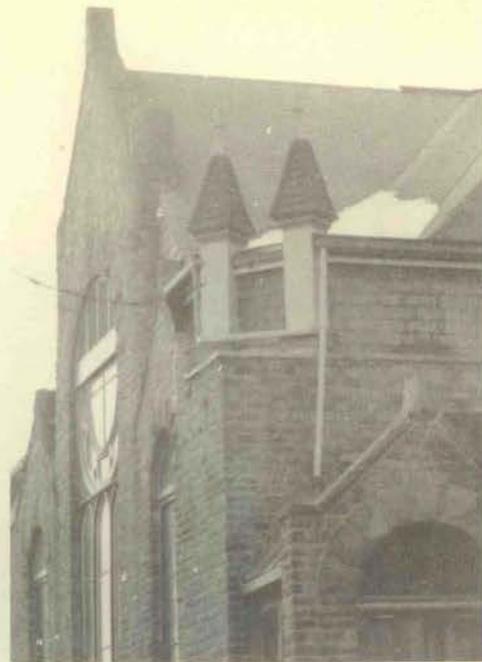
Above: Part of the multiple roofs of 168 Main Street. Nowadays this church has three different visible roofing materials. The main upper portion is now covered with asphalt shingles; the original 1896 roof would have been either metal or slate. The gutters in the valleys of this roof are copper. The very steep portion just below, studded with the two small turrets visible in this picture, is clad with rectangular slates. Behind the parapet at the lower right is a standing seam metal roof. All these materials present individual maintenance challenges, as do the invisible flat roofs on two levels at this corner of the structure.

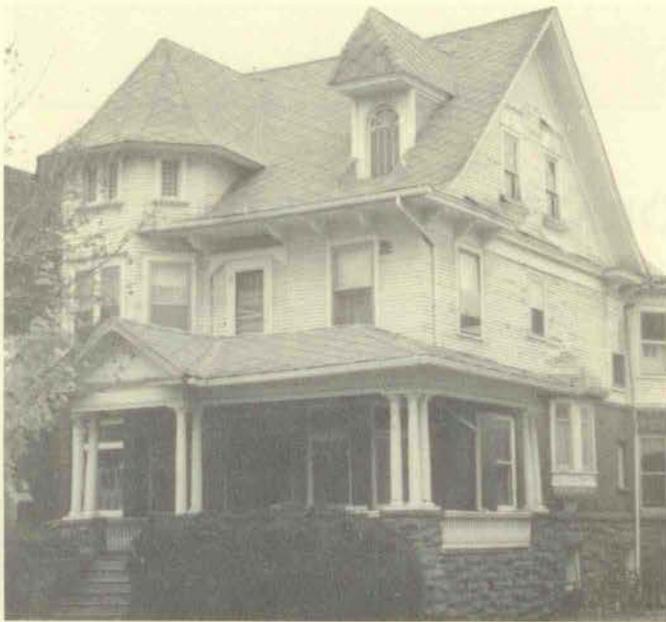
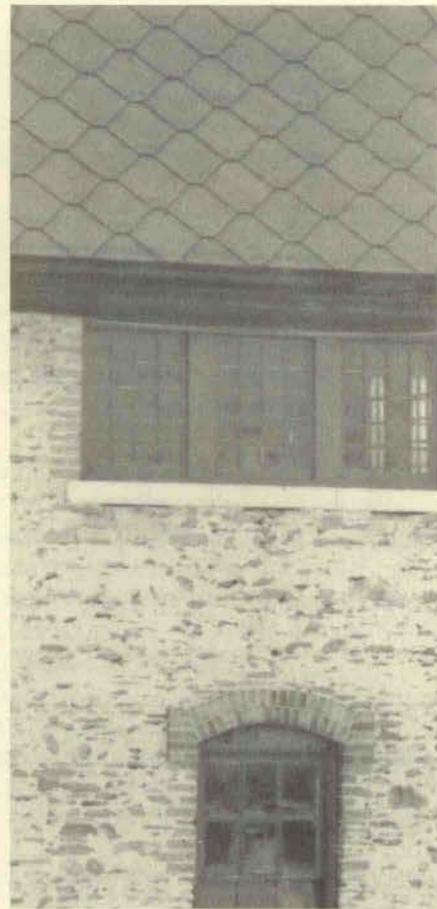
Two examples of the large diamond-shaped asphalt shingles very popular in Penn Yan beginning about the turn of the 20th century. Above, 175 Main Street, a Queen Anne house built in about 1885 by John H. Butler. The roof was reshingled in 1977 and the shape of the dormer altered. Right, the turret of the gas house on Water Street, built in 1898. This is not the original roofing material for either of these structures, but it reproduces well enough the spirit of the original..

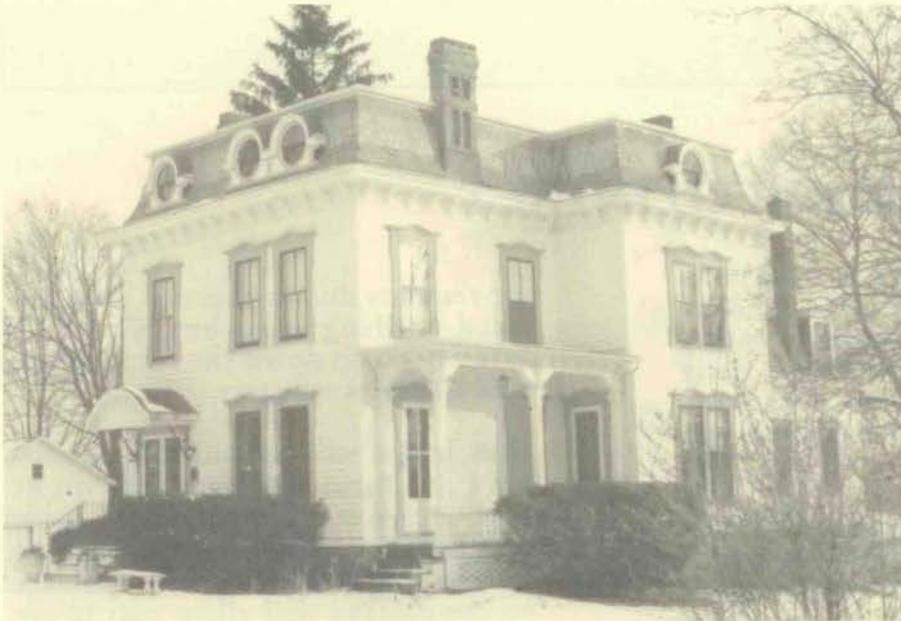
Above: 311 Clinton Street, showing its patterned fishscale slate roof. This house is notable for its refined and elegant design. The subtle pattern of the roof slates, along with other roof features, including the circular dormers and the panelled brick chimney, contribute a great deal to the historic style and personality of the structure.

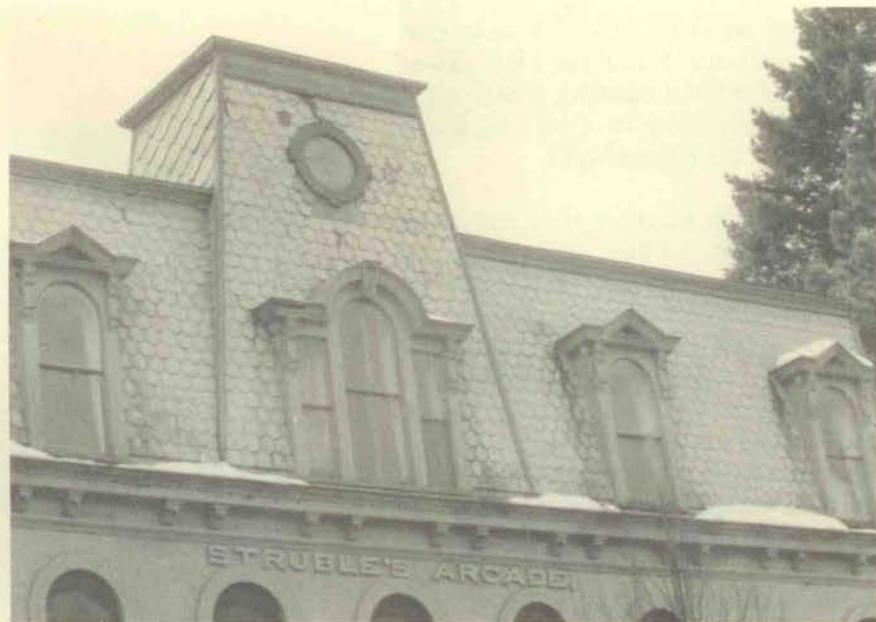
Above: A slightly closer look at fishscale-shaped slates, this time on a commercial building, 144-150 Main Street. This is an extremely rare example of a 19th-century internally arcaded commercial structure. It was a very bold experiment in design, one of several buildings on Main Street constructed by the prominent local builder Charles V. Bush. It is certainly one of his most impressive designs, and the deliberate use of Renaissance shapes for the windows, mansard roof and tower, and rich materials like slate, reinforces this almost aggressively dominant character.

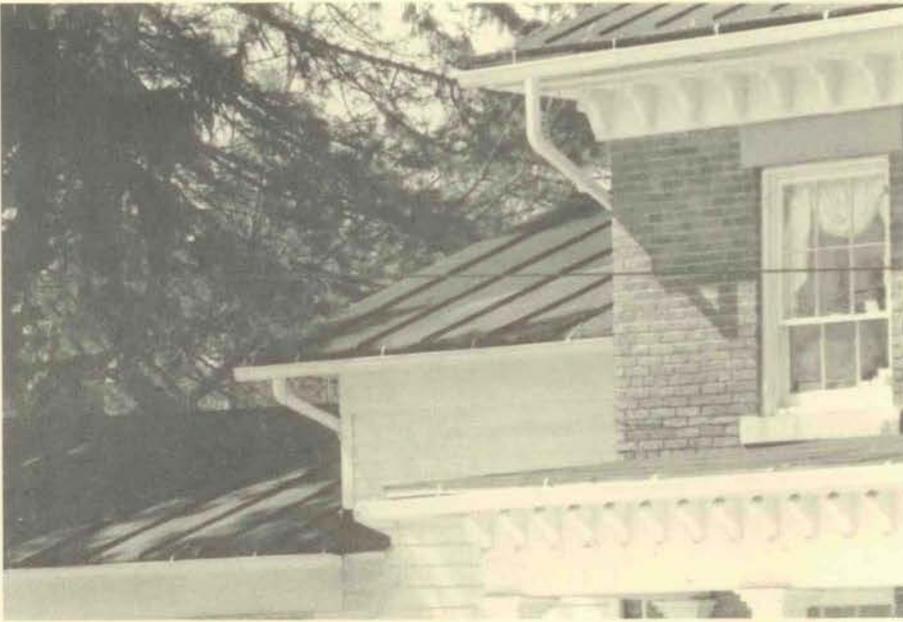
Above: The standing-seam metal roofs of 200 Main Street. These are painted red. They are probably the original roofs of the house, an Italianate structure built in 1852.

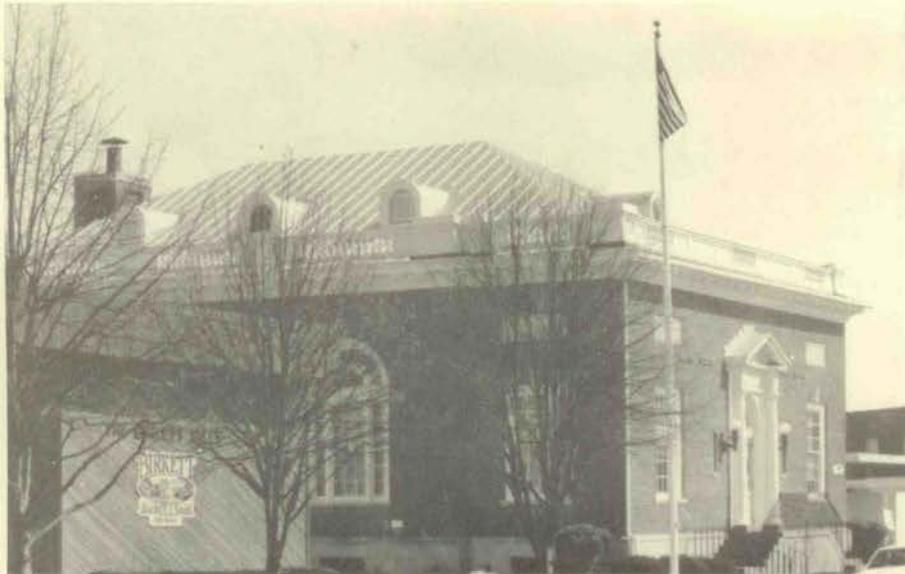
Above: The Post Office, 157-161 Main Street. The standing-seam metal roof on this building is original. The structure was erected in 1912 with excellent materials, demonstrating the continuing popularity and utility of this type of roof.

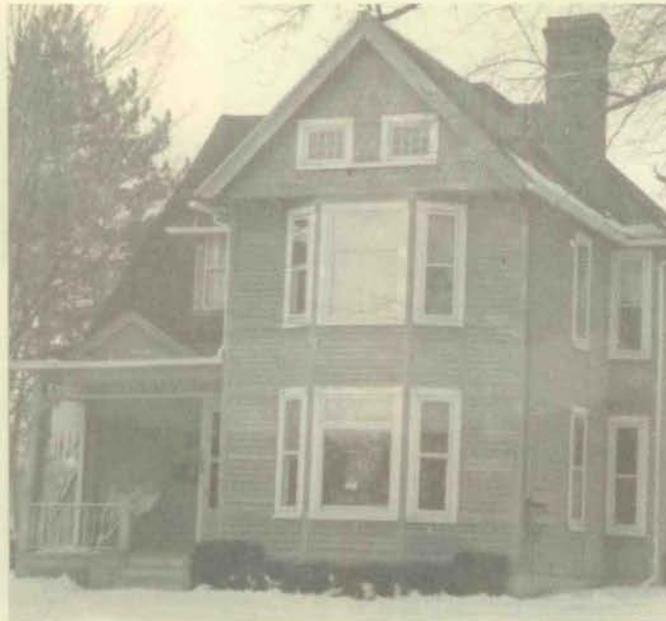
Above: 308 Clinton Street, built in the late 1880s, probably by the lawyer Calvin Huson. It is squarely within the informal Victorian mode followed by several of its neighbors, with fishscale shingles in the overhanging gable, a two-story bay and a modest porch. It is a well-proportioned house, its porch and dormer balanced by the gabled bay. The somewhat irregular massing characteristic of Victorian houses is present and lends it character appropriate to its style. It is an unpretentious, yet quite individual house.

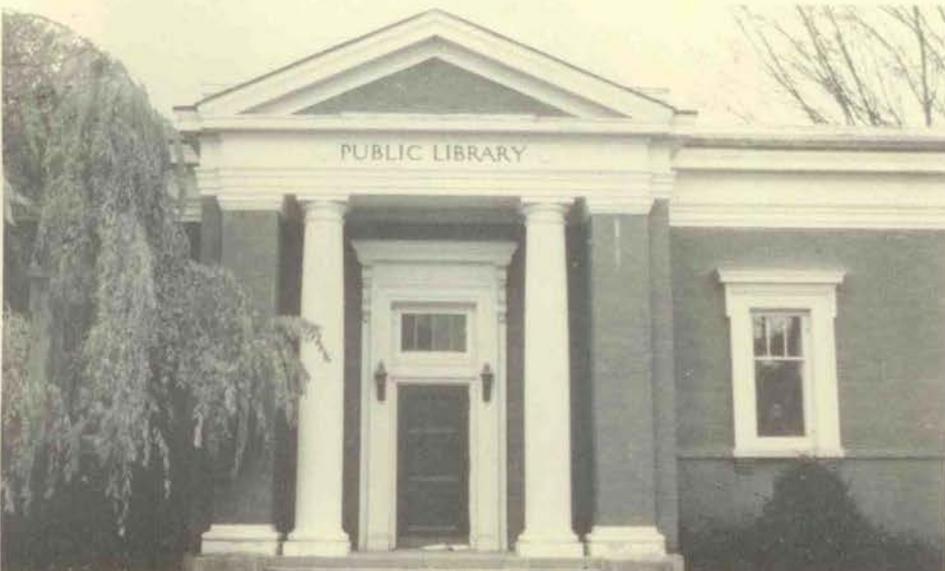
Left: The former main entrance of the library. Because this is a public building the scale is a little larger than life; notice that the actual door is not much larger than that of an ordinary house, but it is made to appear larger and more impressive by the massive surround with its tall transom, and by the framing columns and entablature.

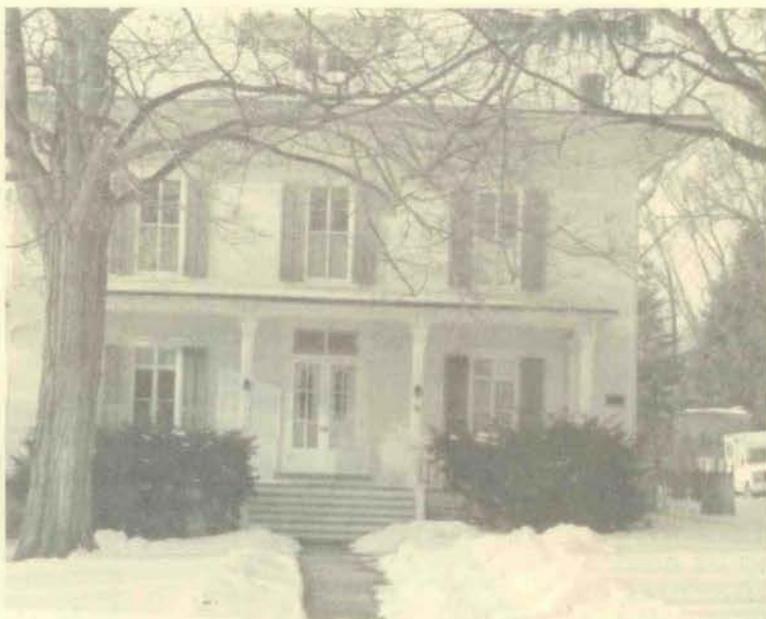
Left: An example of proportions common to many Italianate houses: the facade is about 4 to 3, with the width emphasized even more by the overhanging eaves. The windows, however, are 1 to 2, taller than they are wide.

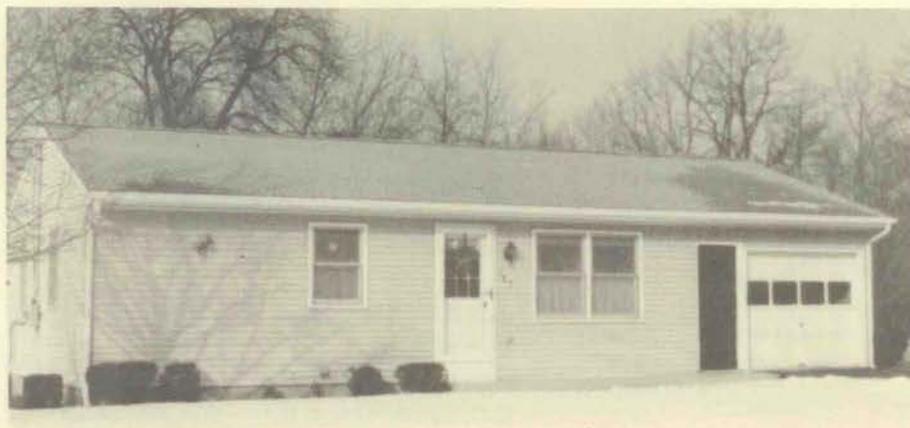
Left: A contemporary Ranch style house with the attached garage yielding a proportion of more than 4 to 1. This is an example of the modern tendency toward horizontal emphasis.

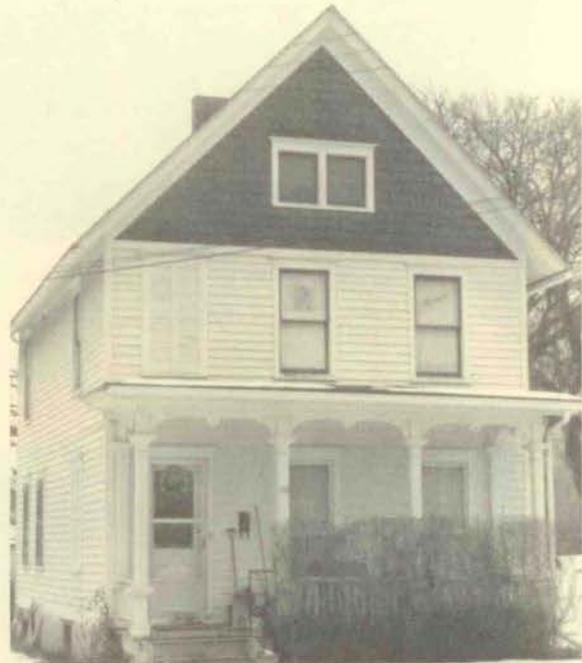
Above: A house's form may be very simple indeed, as in this Homestead style house, a rectangular box with a triangular prism above. The rectangles that make up the facades are repeated in the shapes of the windows. The same shapes in different proportions might yield a completely different style; compare a similar front-gabled Greek Revival house, for example.

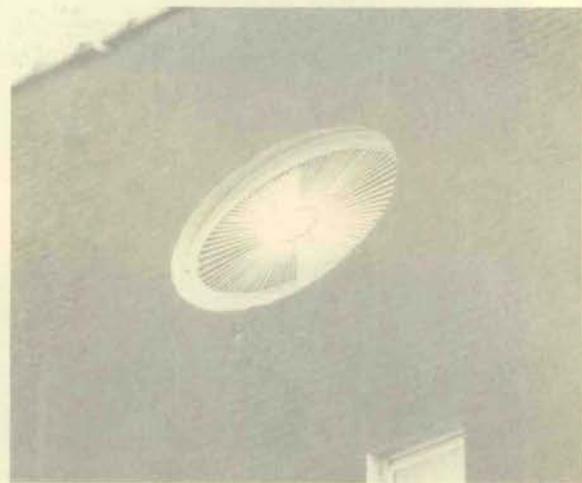
Above: A characteristic shape linked to the Federal style. This elliptical louver in the East Elm Street wall of 25 Main Street betrays the building's early 19th-century origin, despite the later addition of a fourth floor and Romanesque windows. A careful look will show the outlines of the original step gables.

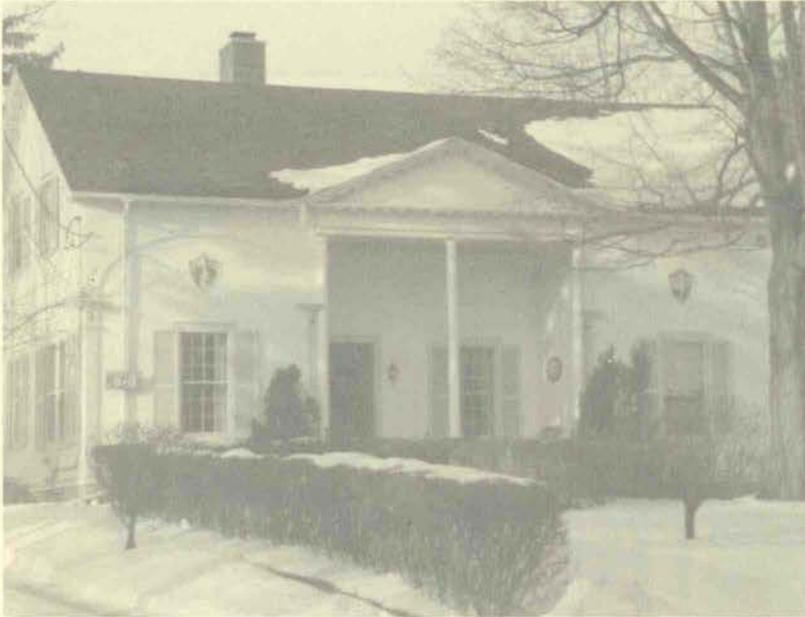
Left: Forms may be subtractive as well as additive. Here a recessed front portico is hollowed out of the plane of the facade. This house is Colonial Revival, and the recessed front entrance is quite often found in earlier Federal houses; not often as grand as this in the local area, however.

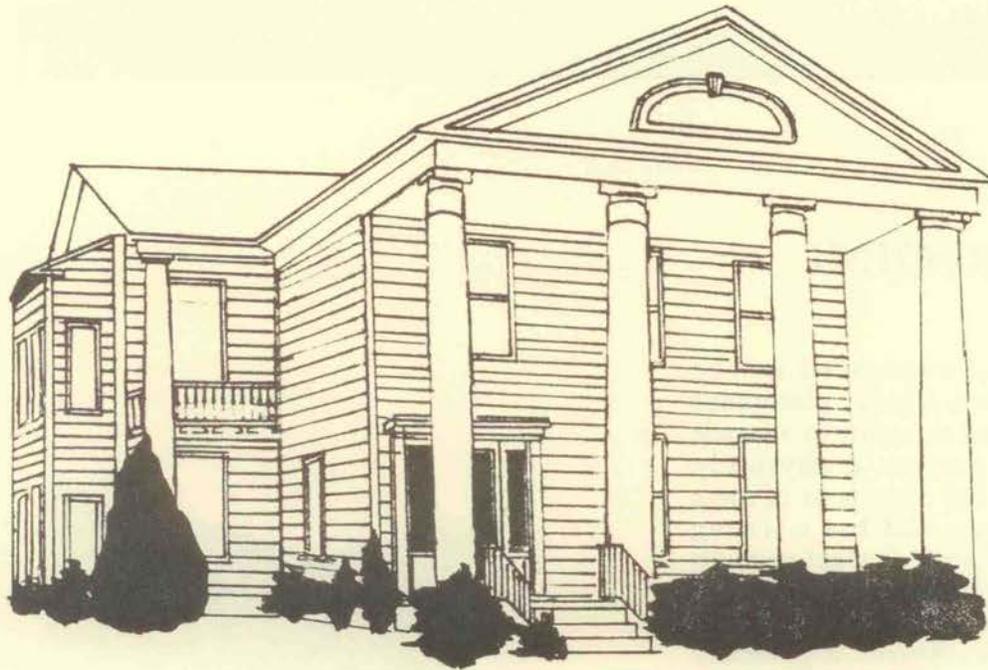
Houses may be very different from one another and yet share certain principles of design. Above: 306 Main Street, a Greek Revival house built about 1831 by Henry Wells. The sketch shows how the front-gable with wing plan so common in Greek Revival buildings allows a great deal of emphasis on the main porch and front entry. The latter is even more strongly emphasized by its massive entablature and sidelights. In an interesting variation, the eye is drawn to the pediment by a semi-elliptical fanlight. Below: 312 Clinton Street, built in the early 1870s by Darius Ogden for his son Darius, Jr. This house has lost an original wraparound porch which extended all the way across this main south facade. However, the main feature of the facade is still the front entry with its portico. As in the Wells house above, the eye is deliberately drawn to the front gable, pierced by a Gothic window and re-emphasized by a particularly attractive lacy scrollwork truss.

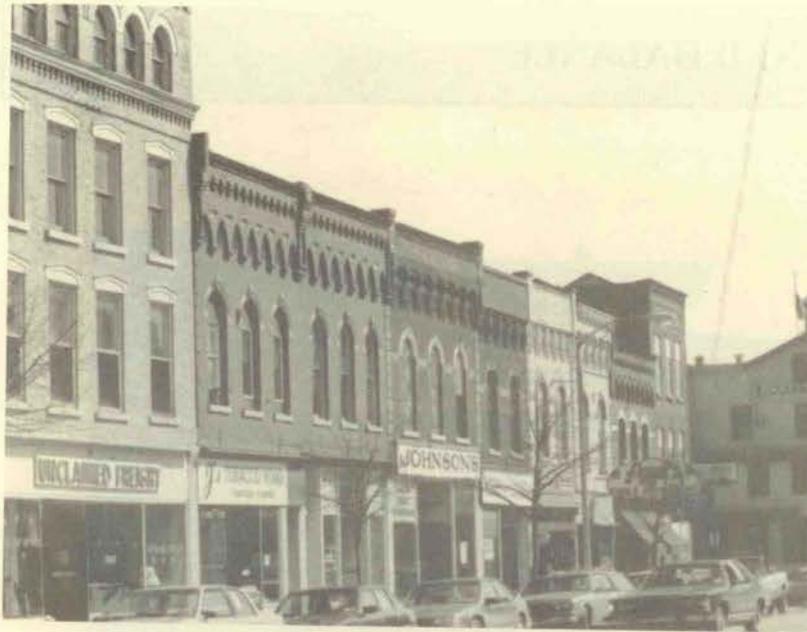
Rhythm is an important factor uniting the component parts of a neighborhood, as well as those of a single structure. Left: The southernmost block on the east side of Main Street, Nos. 1-23. These buildings were put up at different times, in slightly varying styles. Even though the windows are not at the same level, and the cornice decorations do not quite match, these structures form a harmonious block due to the spacing of the storefronts (note how the double building 13-17 is made to fit in), the spacing and size of the windows and the repetitive elements of the cornice.

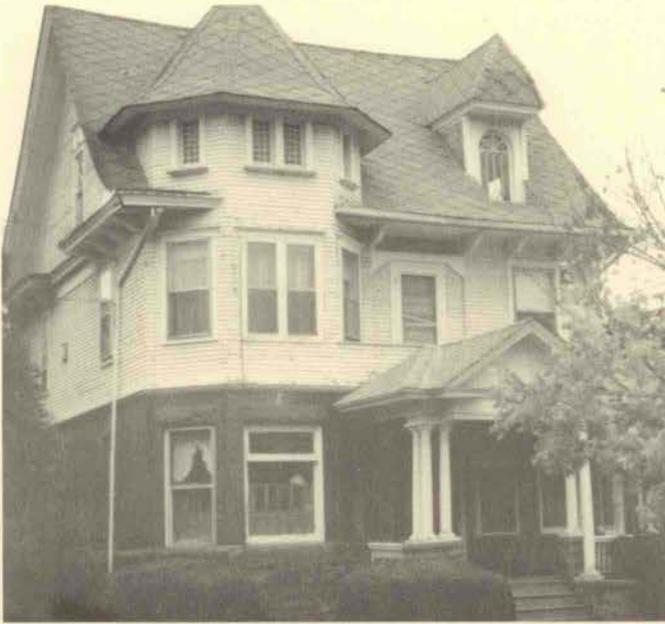
Left and below left: Two examples of dynamic balance. Neither house is symmetrical, but both are balanced. Left is a Queen Anne house with the three-story bay well to the left; the dormer and portico "weigh" as much to the eye. The side-gabled roof is otherwise symmetrical, and the bands of windows running around three sides help pull the design together. Below left is a Colonial Revival house that retains Queen Anne ideas about asymmetrical balance. The facade is rich in detail without being busy; the full-width porch pulls the eye across and binds the whole design together.

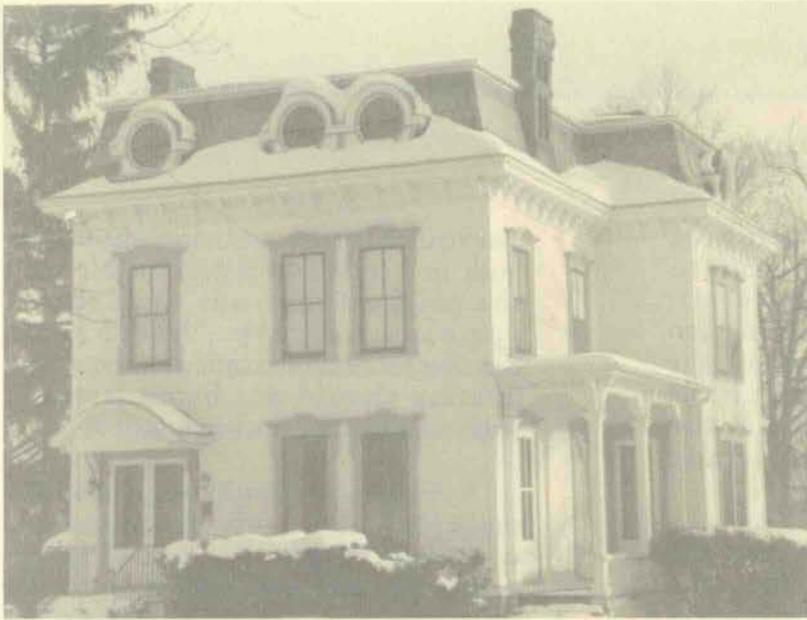
Left: 311 Clinton Street, built in 1869 by Charles Hewins. This is probably the most fully realized example of Second Empire style in Yates County, missing only the original front portico. Every facet of this opulent building was designed to make a harmonious whole, from the patterned slate roof with its circular dormer windows, down through the single and paired windows to the echo of the cornice line in the trim of the porch.

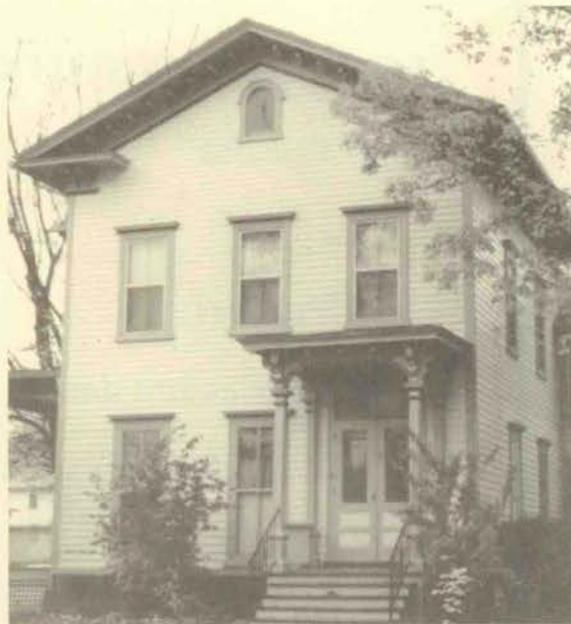
Above: The main facade of 121 Court Street, not much changed from when the house was built during the 1860s. It retains its original rather restrained ornament, its original cladding material, the original shapes of its windows and doorway, and its handsome portico. As an historic structure it has retained its integrity and as a home it has retained its style and livability.

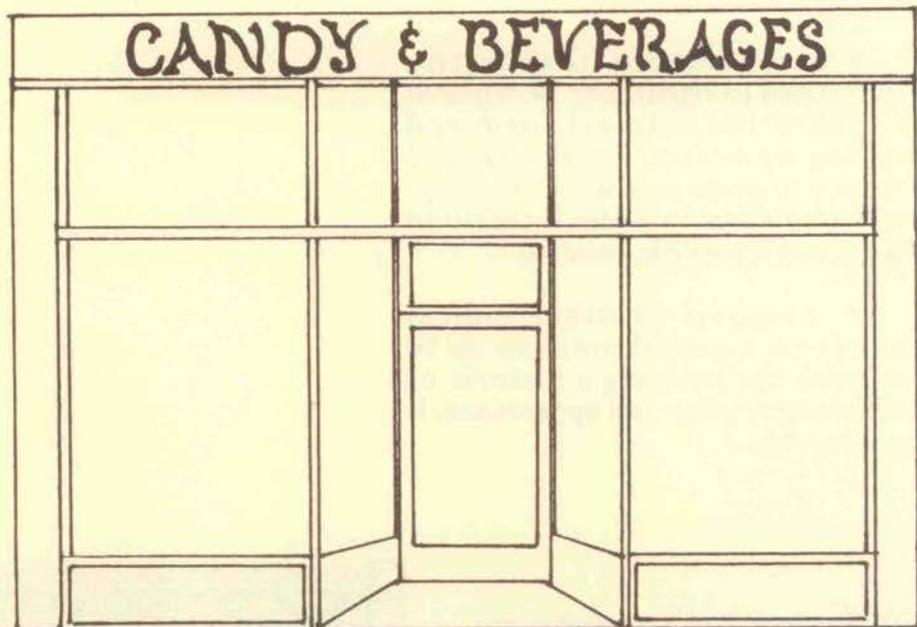
Above: A sketch of a modern storefront such as might be found in a nineteenth-century commercial building. This is a classic three-bay front with a signboard above the transom. The piers at the outer edges of the storefront appear to support the lintel containing the signboard and preserve an outline of the building's structure. In many of Penn Yan's storefronts, these piers are of cast iron and are actually part of the structural skeleton. The recessed doorway is functional, as it shelters customers from the elements while allowing them to view the display windows from two angles.

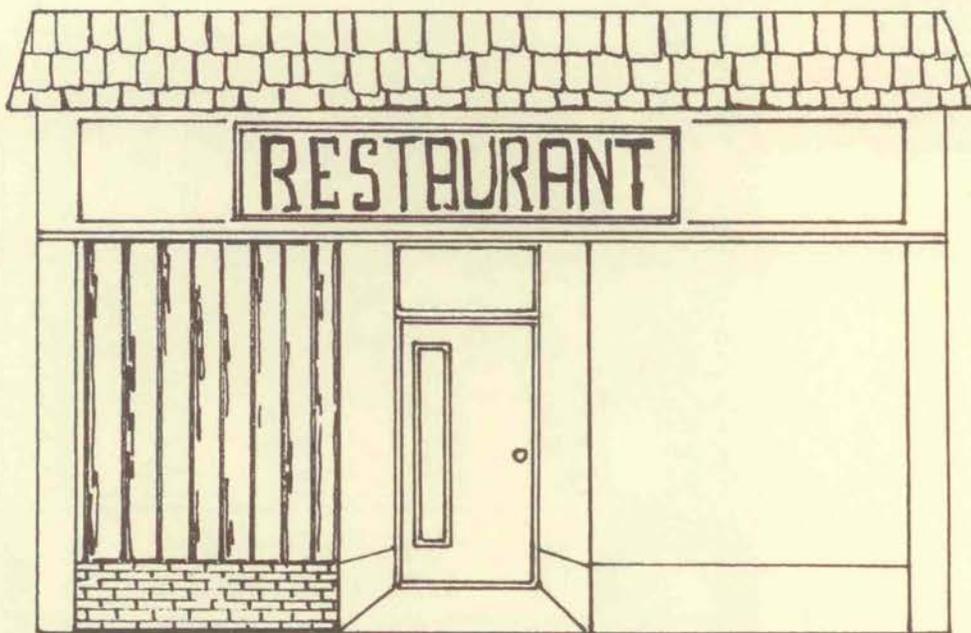
Above: An example of inappropriate change to an historic storefront. The false mansard with its wooden shake roofing is a false attempt at rusticity. A modern door has been substituted for the original glass one, the left-hand window has been obscured and imitation stone applied. In addition, the signboard has been lowered, obscuring the transom and reducing the amount of natural light entering the interior. Most of these changes are well-intentioned, aimed at increasing the intimacy of the restaurant's atmosphere, but they are not appropriate for an historic building.

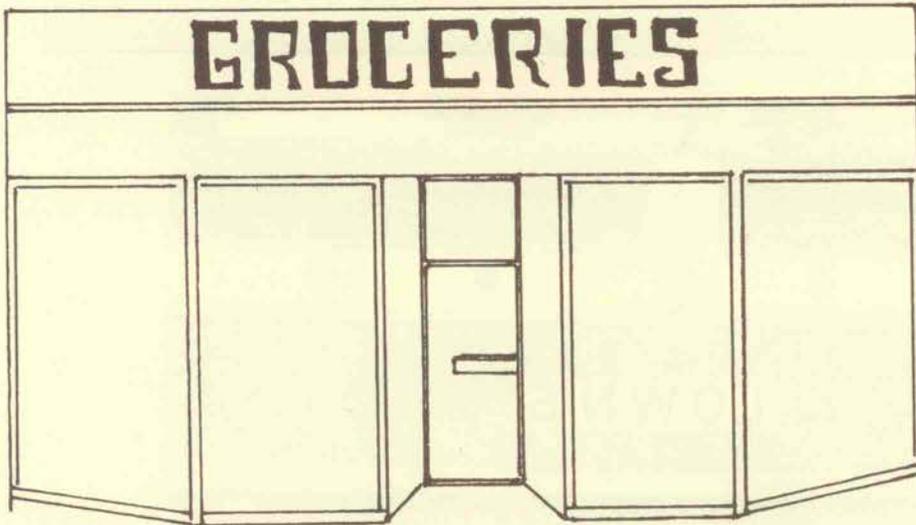
Above: Another inappropriate renovation. Here, the display windows have been extended into a bay, completely altering the storefront. The piers at the sides have disappeared and the result is a featureless front with no relationship to the rest of the building above, or to less altered neighbors. This storefront has lost its historic character and its individuality.

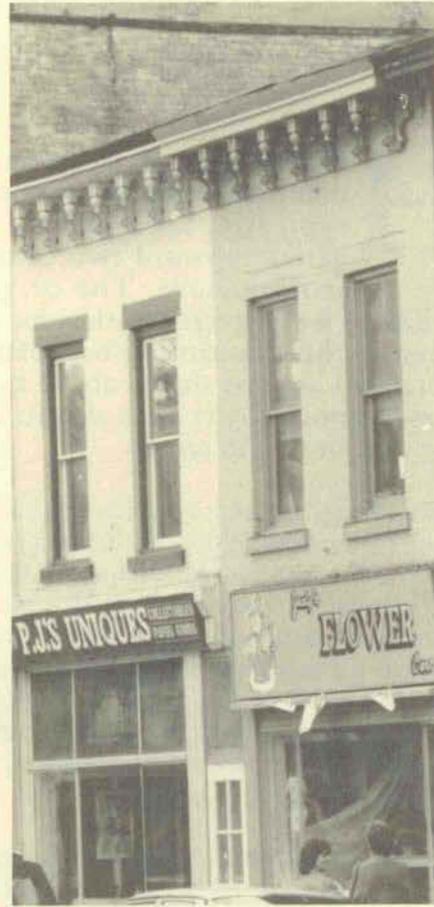
Above: 132 and 134 Main Street, built in 1852 by Charles V. Bush. This is a single building with two storefronts. The plain rectangular windows with their simple sills and lintels are well set off by the graceful Italianate cornice. The sign on 132 Main is almost identical in size, shape and placement to the nineteenth-century signs that preceded it.

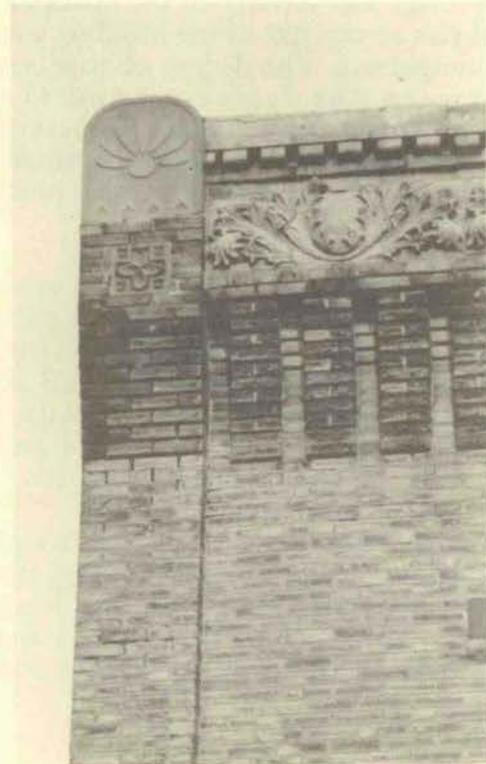
Above: The top left corner of 121-123 Main Street. This is part of the facade added to this building in 1901, a medley of brick, terra cotta and stone. The corbelled brick cornice with its elaborate decoration is absolutely essential to the design.

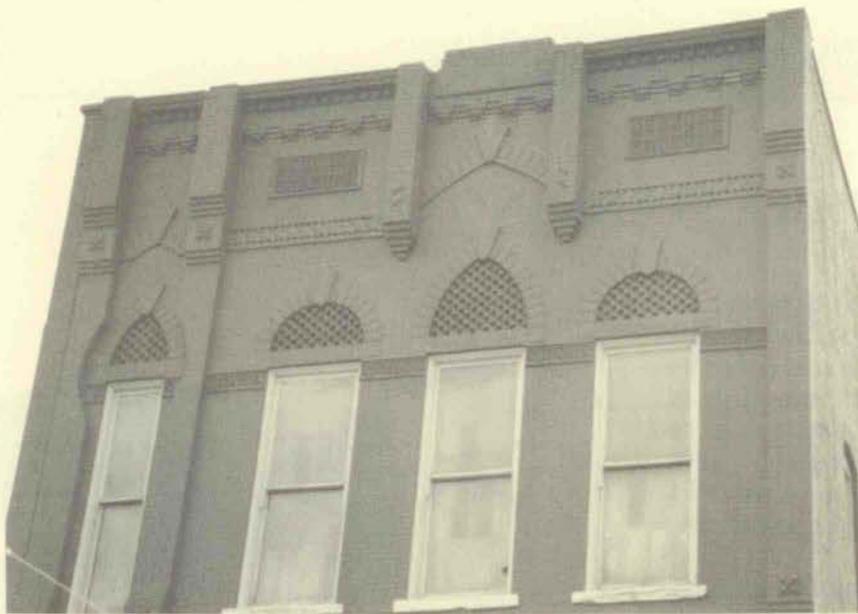
Left: The upper story and cornice of 131 Main Street, showing some of the elaborate brick and terra cotta decoration that make this building unique among Penn Yan's commercial facades. The general effect is quite exotic, leaning toward Moorish Revival. The asymmetrical arrangement reflects the storefront, which is three windows wide, with a side doorway. The original facade was even higher and more imposing than it is now, a row of battlements having been removed around 1920 or so.

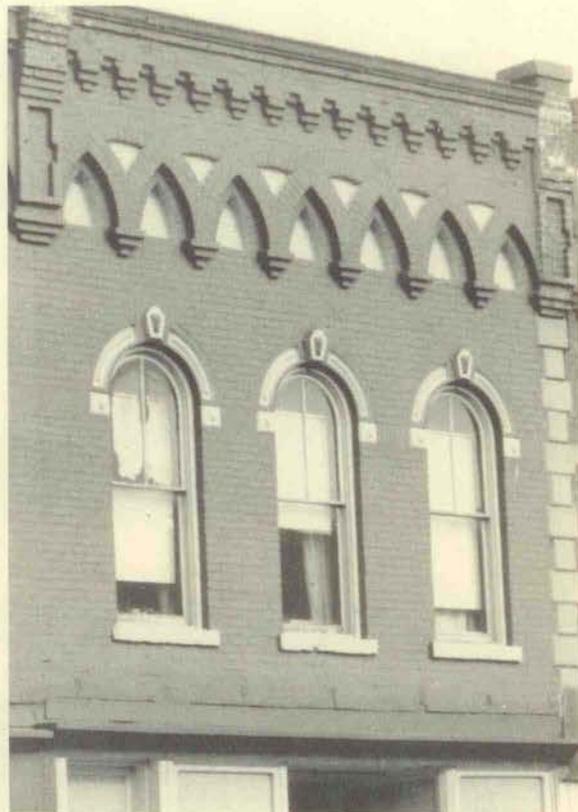
Left: The upper facade of 13 Main Street, built about 1875. This and the building next door to the north were originally the Sheridan House Hotel. The stepped cornice, overlapping brick arches, stone quoins and round-topped windows with keystone moldings are typical of Italianate-influenced commercial architecture of the period. This is half a symmetrical building, now with two storefronts. The windows are the original size and shape and add a great deal to the lightness and elegance of the facade.

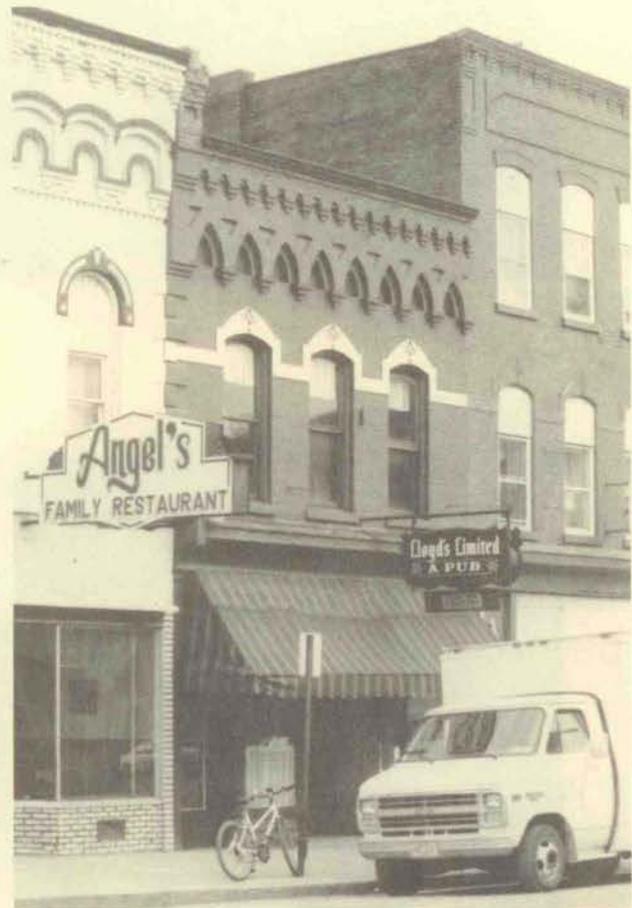
Above: An example of a facade that was successfully reconstructed. The ground floor facade was restored in the early 1960s, and later the upper part of the building was repainted and has been very well-maintained. This is now the original cast-iron storefront of a building that has served its present function nearly continuously since its construction in about 1890. Note the building next door on the right which once resembled it, but received a third story somewhat later and now looks quite different

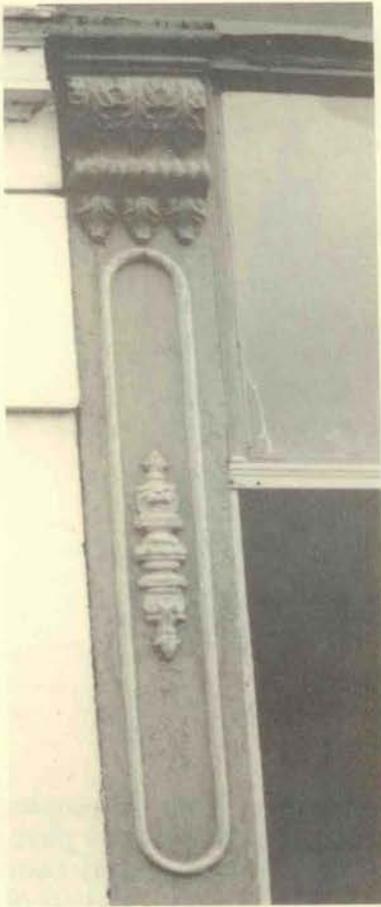
Some examples of structural elements which should be considered when rebuilding or remodelling a commercial facade. Left: One of the elaborate cast-iron piers on the row of buildings along the south side of Elm Street.

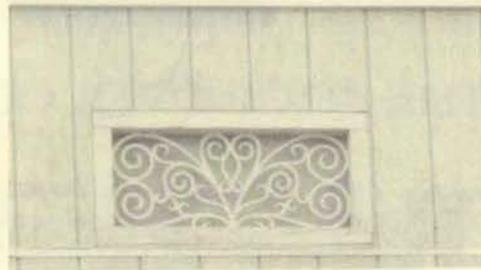
Below: The only feature remaining from the original facade of 124 Main Street. Originally a rather simple 1830s Greek Revival facade, the upper story was removed and the brick covered with textured plywood siding. This elegant and delicate grate once covered a frieze window between the third story and the brick cornice.

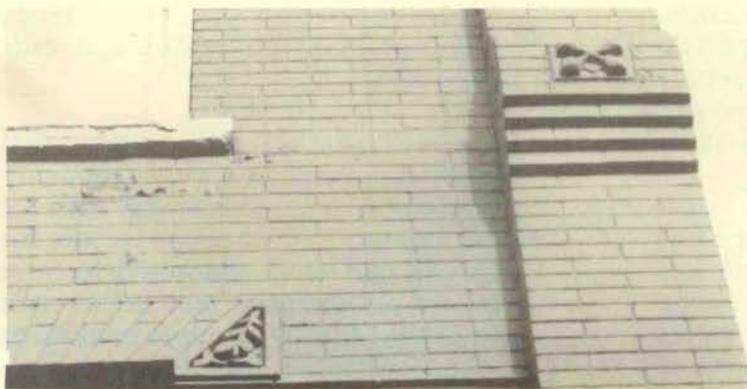
Right: The brick lintel and terra-cotta decoration of a window at 131 Main Street. These kinds of elements are extremely difficult to reproduce, and yet they add the richness of detail that makes the village's commercial district so attractive.
