AN INHERITANCE OF TIME

Guidelines for the
Village of Penn Yan's
Historic Preservation District

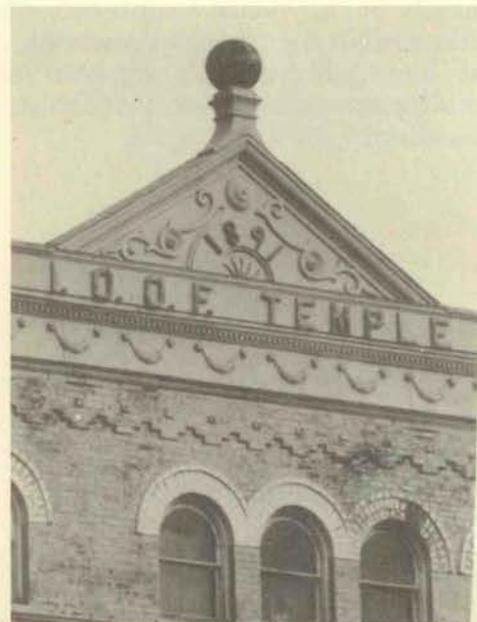
Above: The pediment and part of the cornice of 19-23 Main Street. This building was erected in the late 1860s, and completely altered in 1891 with the addition of a fourth story and this cornice by the local Odd Fellows' chapter. The bold ornamentation, with its swags, scrolls and inscription; and the pediment surmounted by its pedestal and once-gilded ball, certainly define the character of the building as it now stands, and should be considered in any plans that might involve the facade or roof of this structure.

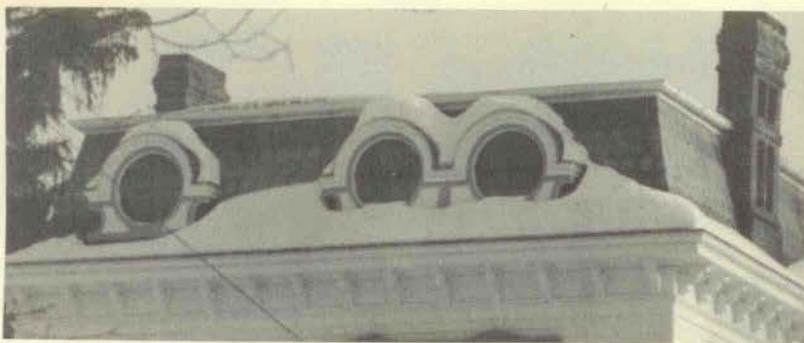
Left: The mansard roof of 311 Clinton Street. Note particularly the circular dormers, spaced to reflect the second-story windows below them; and the panelled brick chimneys. Both give this impressive house a special elegance.

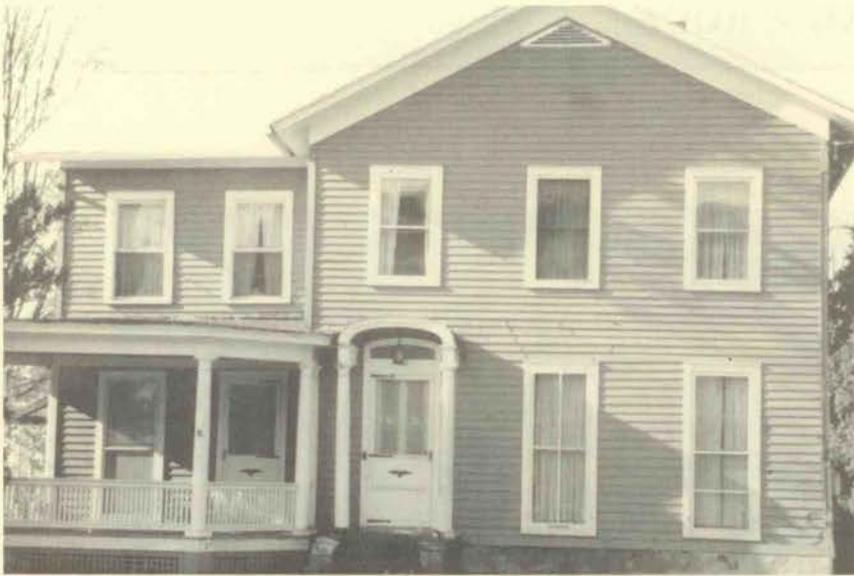
Above: This Liberty Street house was originally built in the Greek Revival style, the first-floor windows and entrance altered in the Italianate period, and the porch added still later, possibly around the turn of the century. The pitched original roof provides efficient runoff of rain and melting snow, but the porch roof is virtually flat and without eavestroughs on the roof above would receive a great deal of water. It is slightly pitched to avoid the worst consequences of this, but maintenance efforts will need to take this configuration into account to keep this house in as good condition as it is today.

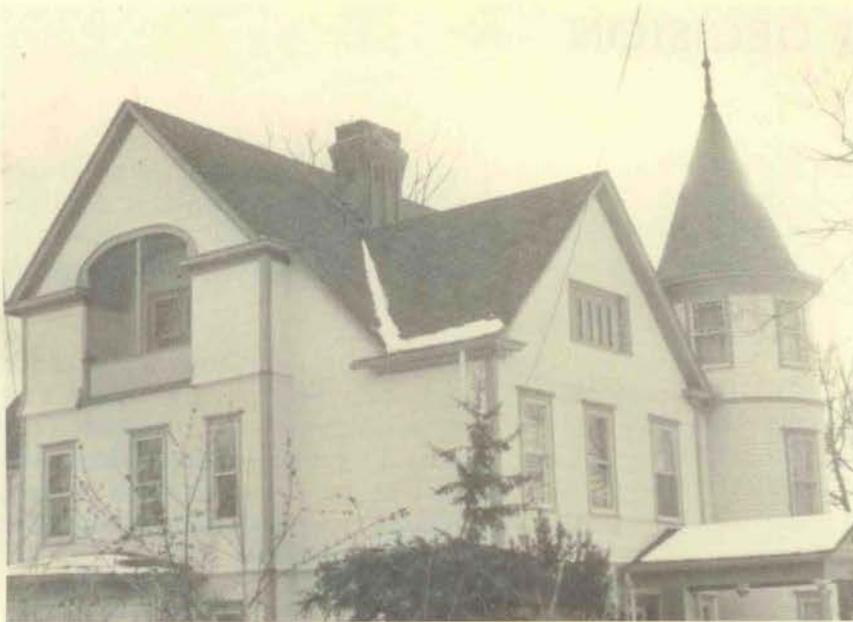
Above: 303 Clinton Street. The gully between the gables channels water into an eavestrough. Note also the conical roof of the tower, which will present its own maintenance challenges; the finial on the tower is an important architectural feature and must also be maintained.

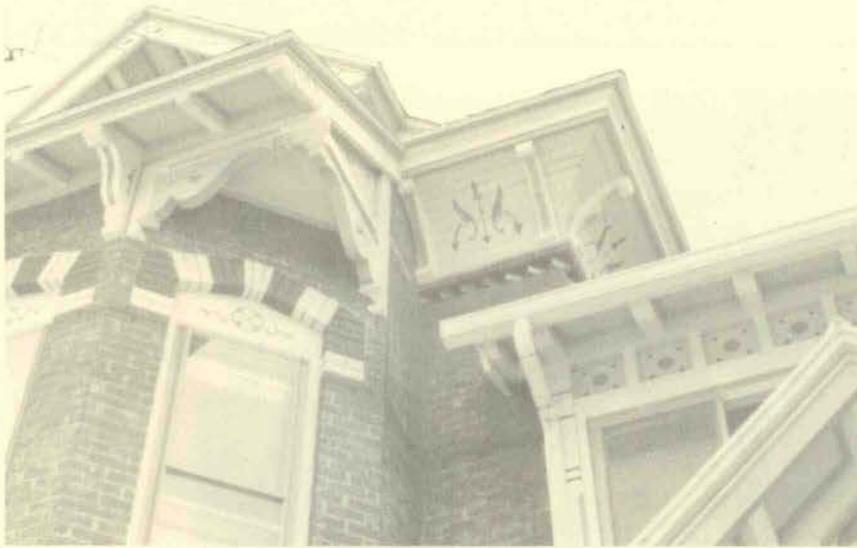
Left: Some Victorian houses have particularly complicated roof designs. Good maintenance is the key to preserving architectural features like these wooden cornice ornaments, but if repair becomes necessary, the project should contain elements that protect the integrity of the rest of the building. Roof repair is expensive; and a repair project should increase the value of the structure, not diminish it.

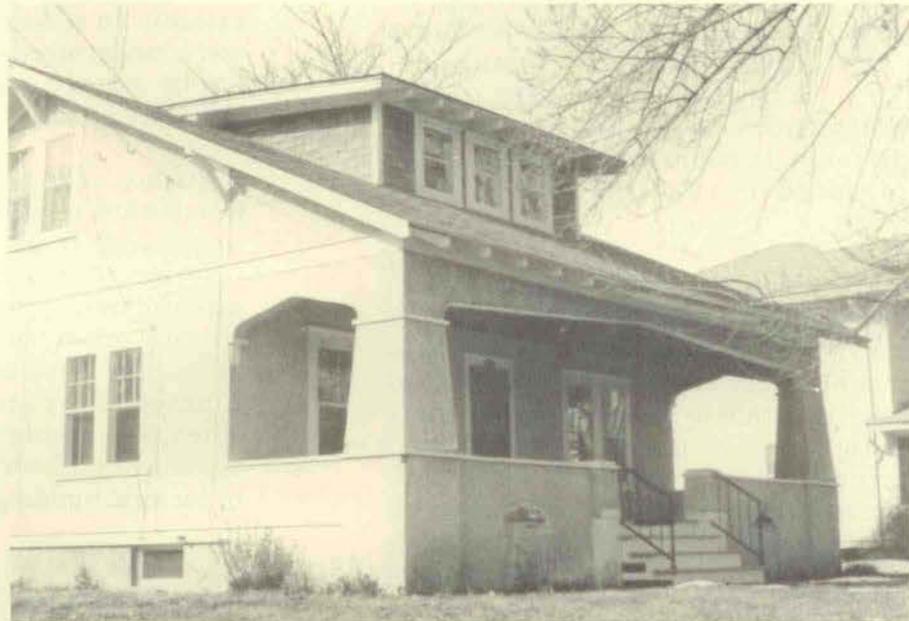
Above: Even relatively simple roofs, such as the one on this bungalow, have individual architectural features that should be considered before a repair project is undertaken. In this case, the shed dormer, the knee brackets under the gable and the exposed rafter ends on both dormer and main roof should be preserved and left unobscured.

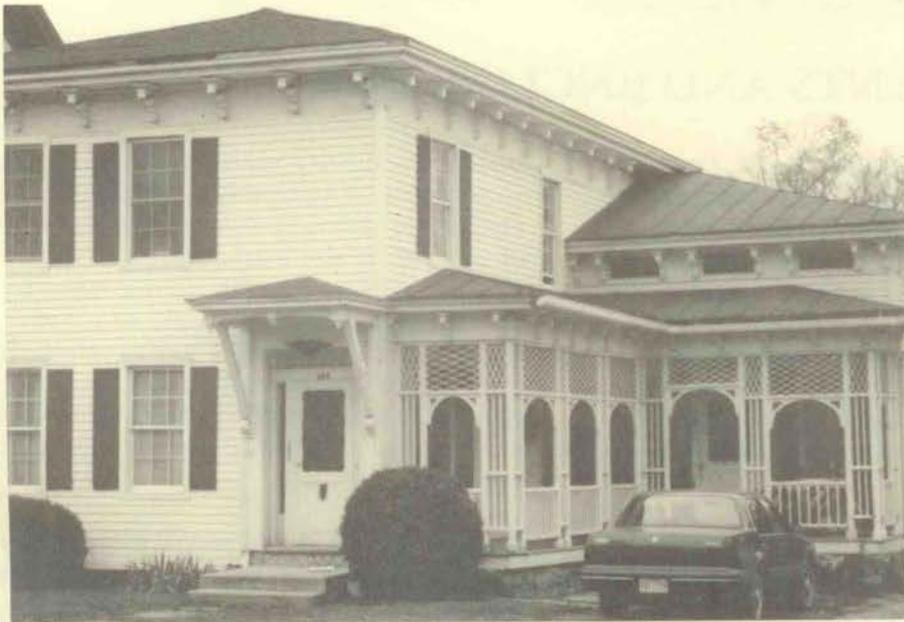
Above: 169 Main Street, built about 1854 in the Italianate style, with one of the most unusual and attractive porches in Penn Yan. The latticework is unique in the village, and gives this otherwise quite plain house a very individual character; the eyebrow windows in the south wing are also unusual in a building of this period. The house was built as a private residence, but served in the late 1850s as a private seminary for young ladies and gentlemen.

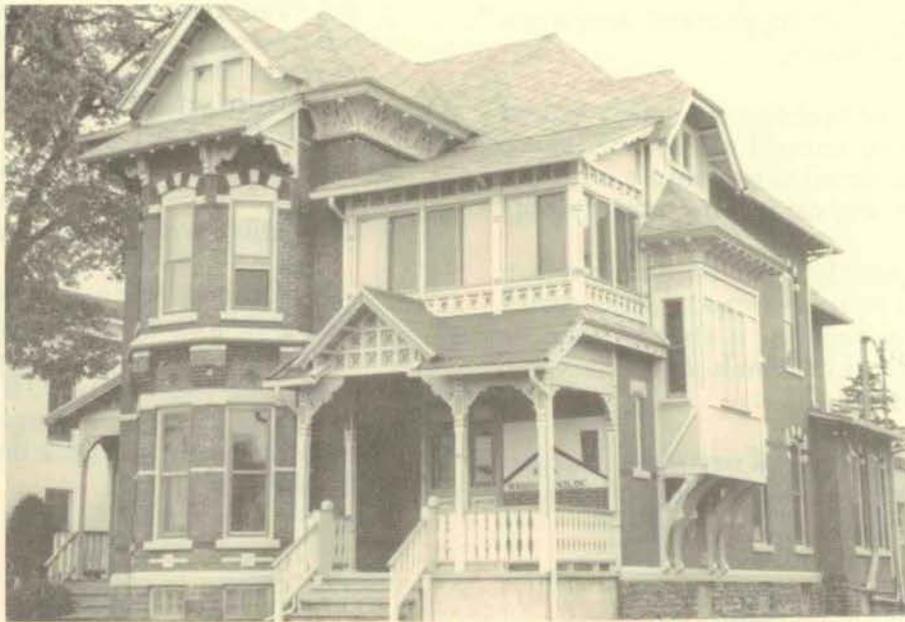
Opposite: 115 North Avenue, an interesting stylistic mixture of Greek Revival and Italianate, with an early 20th-century Colonial Revival porch. The columns and railing of the west wing porch were replaced at the same time as the porch on the north gable front was built. It has a pediment, Tuscan columns and a slatted railing between the supporting piers. The entablature of the west wing porch bears the same very delicate dentil molding as that of the main wing above it.

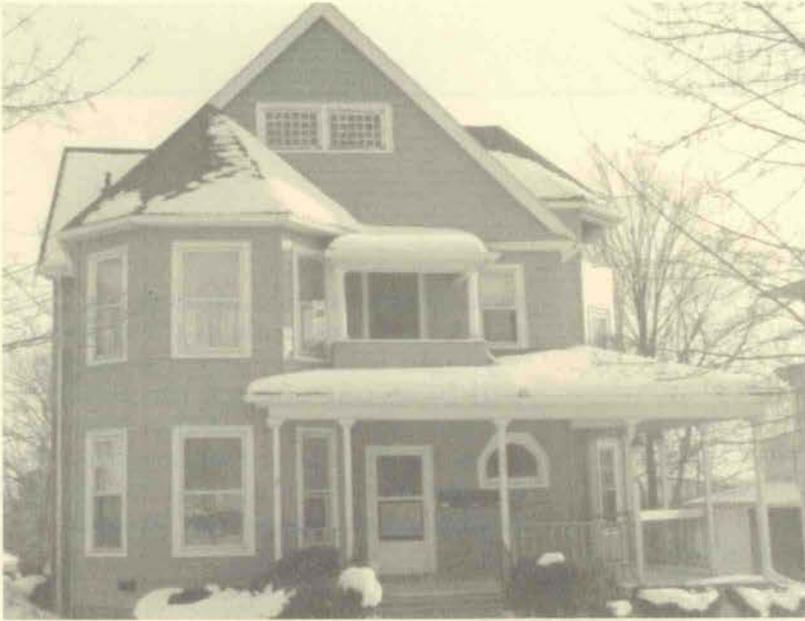
Left: The north front of 307 Clinton Street. This house was built about 1890, a late Queen Anne structure with irregular massing and multiple porches. The second story porch on this facade is of the type that is all too often enclosed to make a small uncomfortable room. It retains the classical columns that were removed from the main first-story porch. Notice another upper porch in the bay around the corner to the west. These small porches add an amenity to the rooms they adjoin, and lighten what would otherwise be a rather heavy design.

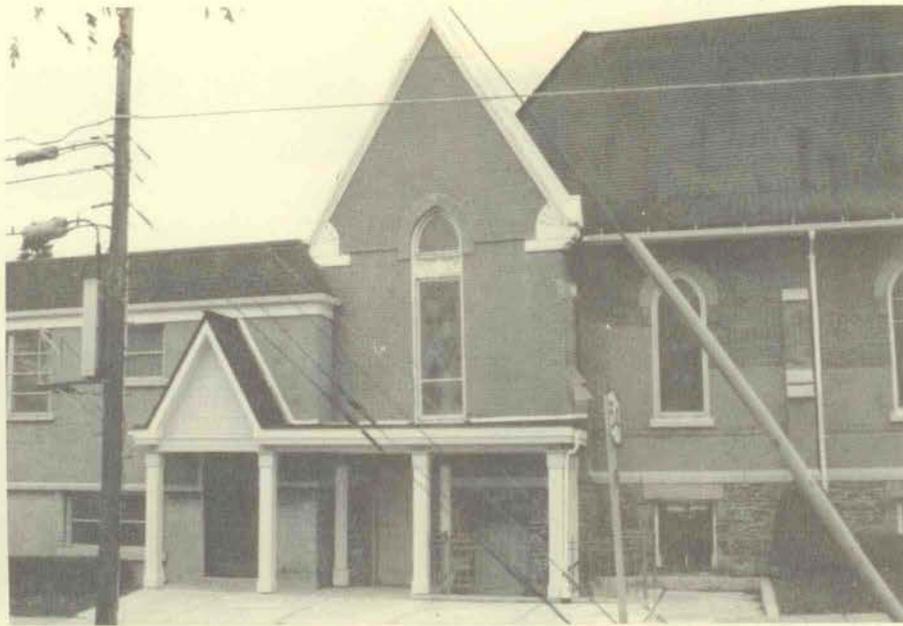
Above: The new entrance porch on the Clinton Street side of 179 Main Street, St. Mark's Episcopal Church, originally erected in 1879 and enlarged in 1888. The new porch was completed in 1992. It binds the church to the hall behind it and echoes the steep triangular gable above with its white-painted wooden trim; on the other hand, though its style is compatible with the earlier part of the building, it makes no pretense of being older than it really is.

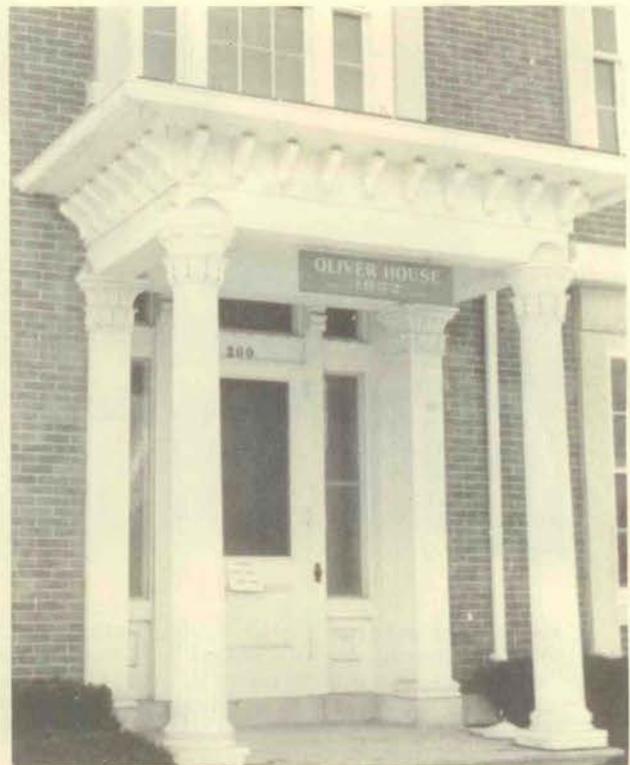
Above: The front entrance of 200 Main Street. This is an Italianate house with some unique trim features. The small, simple and closely spaced brackets are repeated at the eaves and in fact on other houses in the village. The door itself in its shape owes more to Greek Revival ideas than Italianate, and so, really does the columned portico; however, the leafy capitals of the columns and the pilasters are found nowhere else in Penn Yan. The portico's low-pitched roof and wide overhang share the house's general Italianate style and help to define it.

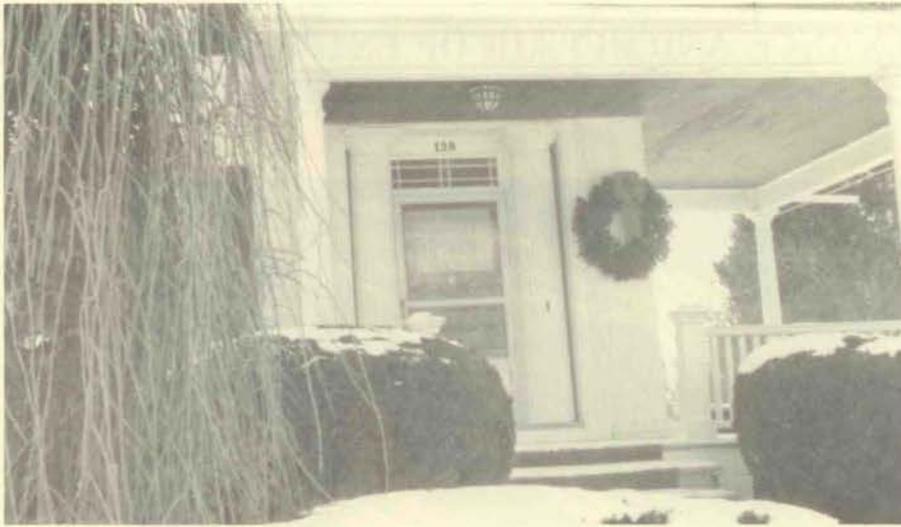
Left: The beautiful front entrance of 129 Clinton Street. The porch and the door itself date to about 1900, but the two framing Doric columns evidently were part of the original 1834 structure. The doorway is recessed into the plane of the facade; the massive solidity of the entrance is in sharp contrast to the general lightness of the remainder of the trim, confined in the rest of the house to the corner pilasters and small dentils under the eaves.

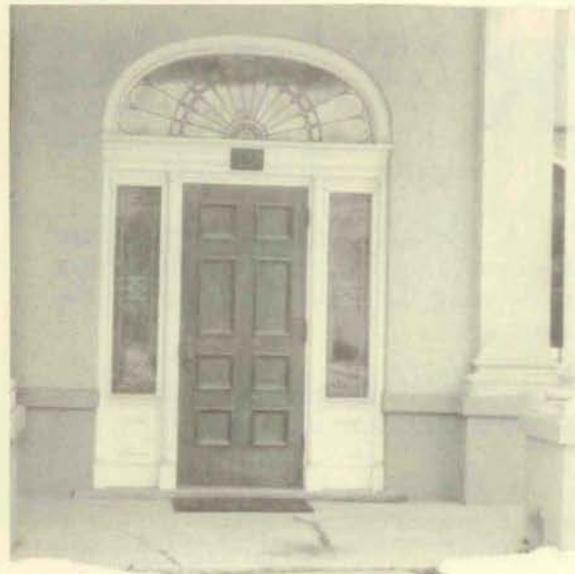
Below: The main entrance of 166 Main Street, built about 1910 when the remodeling was done. This is essentially a reproduction of a Federal door, done in a somewhat flamboyant Colonial Revival manner. The glass in the fanlight is iridescent; the sidelights are also leaded. The slender pilasters and the delicacy of the moldings is quite authentic.

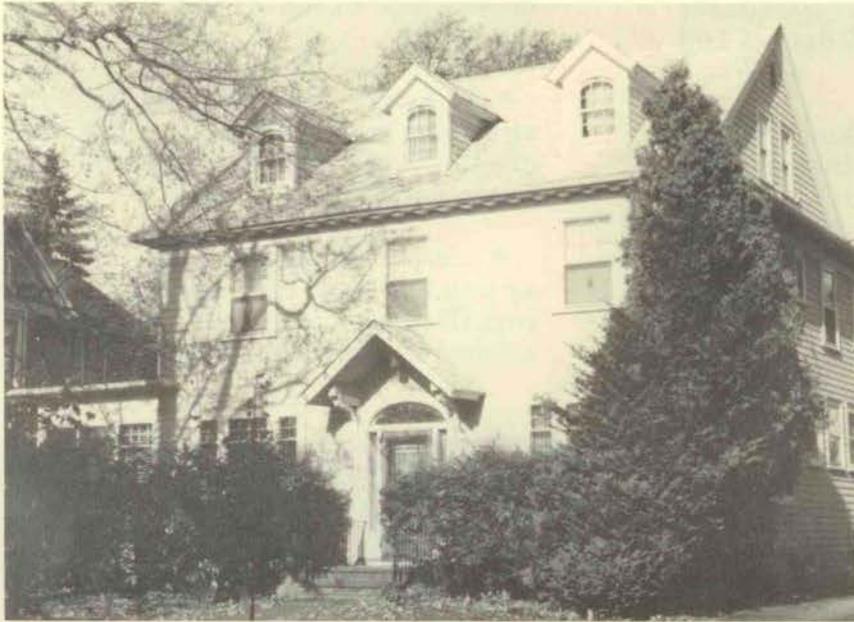
Left: The facade of 117 Court Street, a Colonial Revival house built in 1906 with an impressive Federal-style doorway. In keeping with the restrained but closely detailed design of this house, the doorway is the main focal point of the facade.

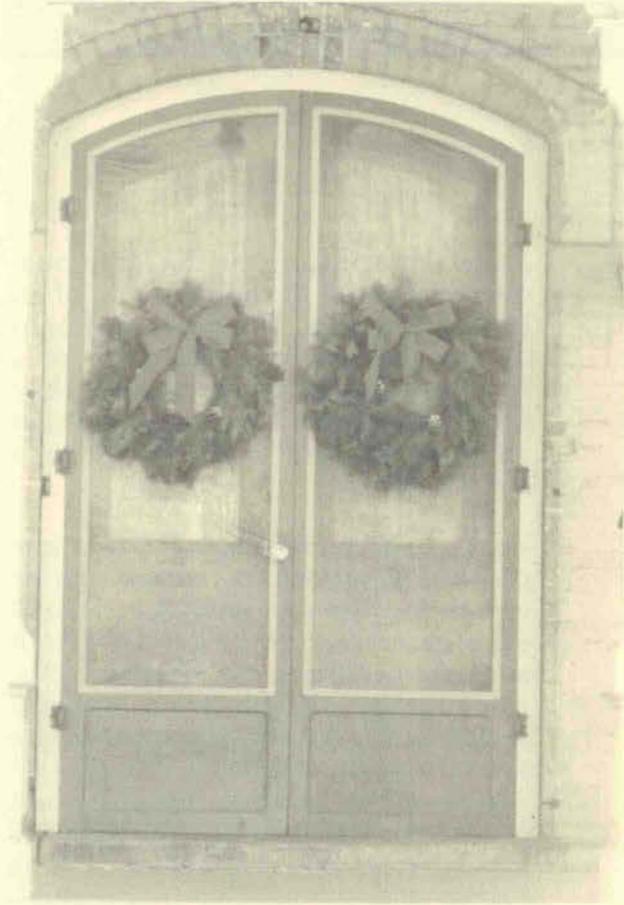
Left: The front doors of 342 Main Street. This is one of the many Greek Revival houses in Penn Yan that were modernized when the Italianate style became popular. The double main doors with the shape of their glazing echoing the shape of the main Italianate arch of the opening date from the 1878 alteration of this 1830 stone structure. The brick doorway surround was built at the same time. The outer doors are the same shape and size, they fill the entire surround, the shape of their openings reinforces the shape of the inner glazing, and nearly the entire inner door is revealed.

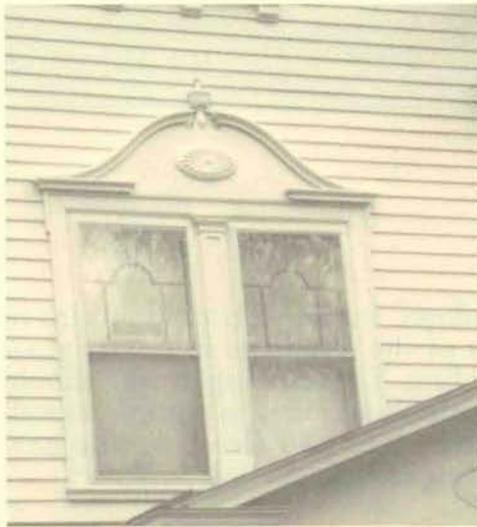
Above: One of the windows in the south facade of 309 Main Street. This is a Colonial Revival house built in 1909, with a wealth of very fine detail. The moldings of this window, with its curved pediment, elliptical sunburst, urn-shaped finial, mullion pilaster and carved frame repeat and enhance themes stated elsewhere in the facade. Note also the leaded panes in the upper sash, typical of early 20th-century windows.

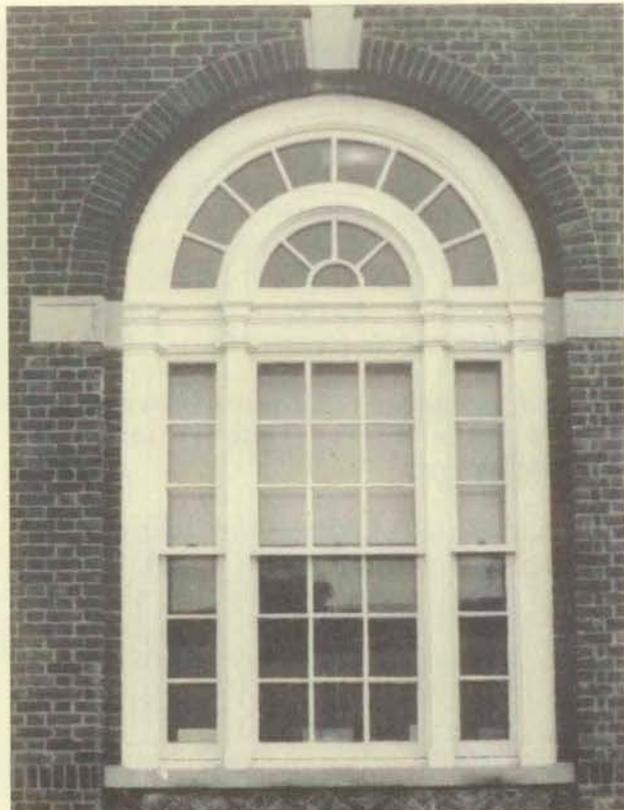
Right: One of the great arched windows of 157-161 Main Street, the Penn Yan Post Office. The brick and stone arches surrounding the rather solid pilaster-and-arch wooden mullions yield dignity to the design, while at the same time lightening it. The relatively small panes of glass contribute to the Colonial Revival style of the building. Note the radiating muntins in the top of the arch.

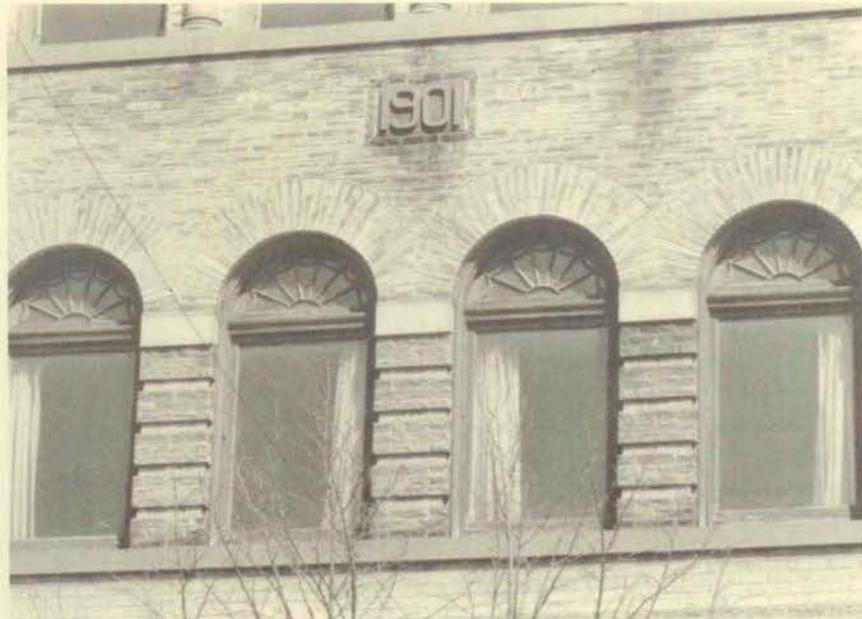
Above: The windows in commercial buildings may be as important in defining their character as those in residential structures. Planned renovations should retain details such as this band of arched and leaded windows; if any should have to be replaced, the shape, size and sunburst tracery in the arch should be retained. Such practices as boarding up part of a window would in a case like this deface a carefully-designed facade that adds a great deal to the prosperous atmosphere of Main Street.

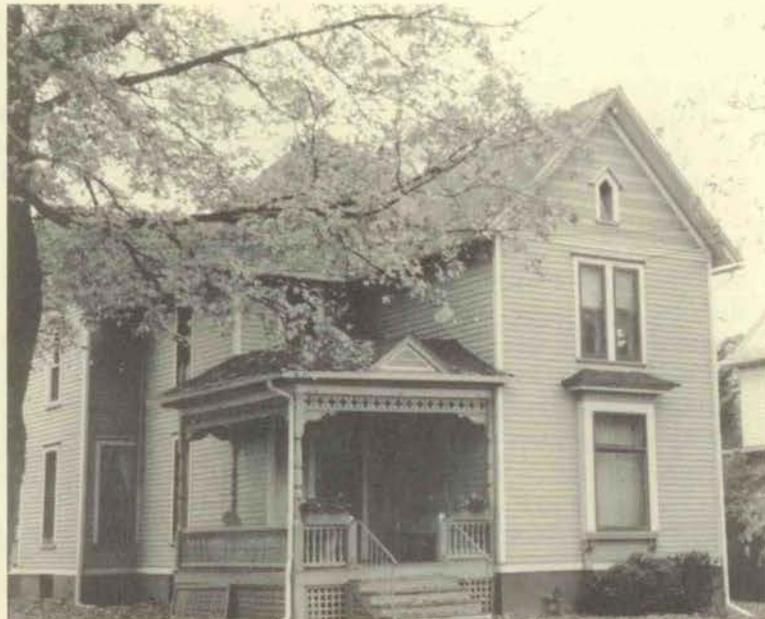
Opposite: A window on the front of 202 Main Street, probably original to this turn-of-the-century structure. Like other appropriate storm sashes, this one fills the frame and has the same divisions as the main window within.

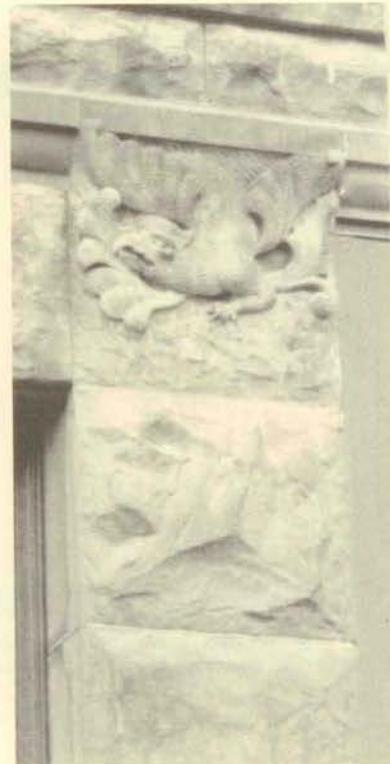
Opposite: A close look at the fantastic detail on the front portico of 208 Main Street. The rope molding is repeated on the doorway itself, just visible in the picture. The general effect could easily have been heavy or too-busy; but the delicacy and skill with which all these varied elements were designed and assembled, and the care with which they have been maintained, make this one of the best examples in Penn Yan of meticulous nineteenth-century imagination and workmanship.

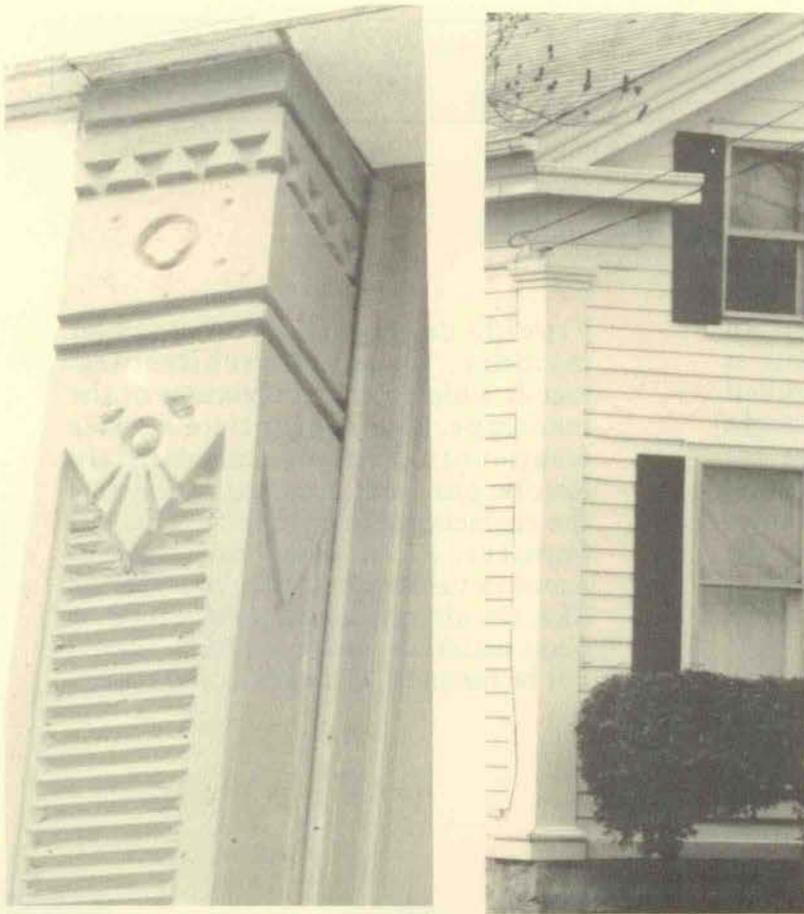
Trim elements with the same visual function may serve different structural needs. Far left: A cast iron pier at 116 Main Street. Near left: One of the cornerboard pilasters of 210 Clinton Street. The former is of course one of the supports of the building's facade, but the latter is pure trim, an essential feature of the building's Greek Revival style, visually supporting the entablature and cornice, but of course functionally doing no such thing. Both these features deserve proper maintenance, however; the one being metal and requiring the care appropriate to prevent corrosion, the other being wood, and needing protection from weathering and decay. Neither should be obscured, damaged or removed without replacement in kind.

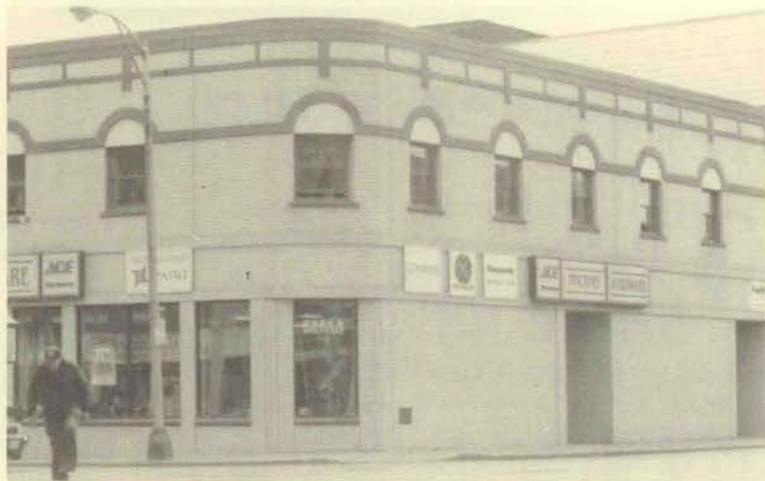
Right: 24 Main Street, an example of new construction replacing an old building; after the 1840 original was destroyed in a 1987 fire, the owners rebuilt. They did not attempt to recreate a copy of the much larger and more elaborate original, but did use light-colored brick with darker trim, and kept the rounded corner in homage to a much-loved landmark.

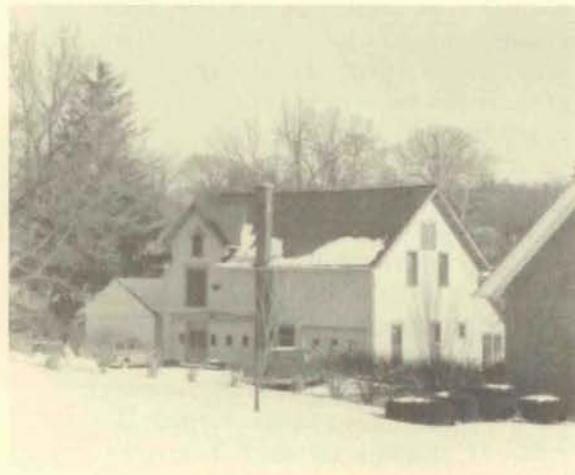
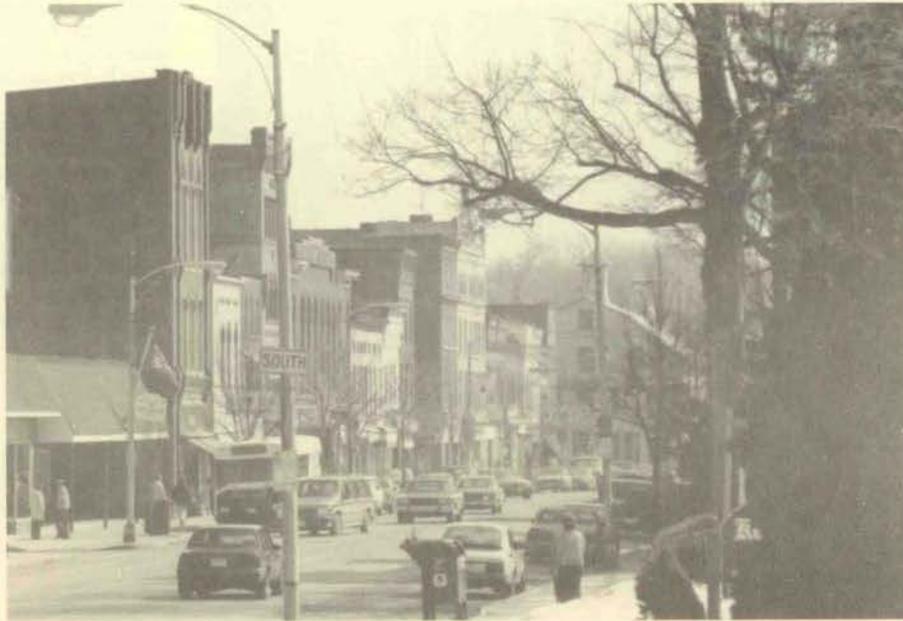
Right: A more distant view of the former carriage house on the opposite page, showing its relationship to the main house. A driveway leads down to it and opens up into ample off-street parking. This can often be a problem when single-family residences are converted into multiple-family rentals, and should always be considered when such changes are proposed. Avoid situations where cars must be parked on the street or, worse as far as the historic property is concerned, on the lawn.

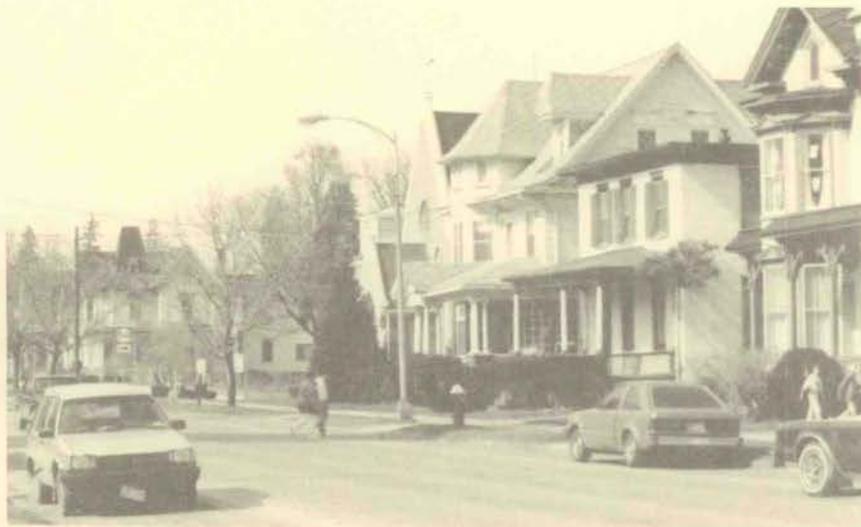
Right: A view north up the east side of Main Street. This vista changed a great deal during the 19th century, and lost much when the great Presbyterian church burned in 1968. Fire has reshaped this neighborhood more than once, though, beginning in 1841 when one consumed the very first frame house in the village, built by Abraham Wagener after his father's death in the summer of 1799. The Wagener house stood where the brick building second from the right now stands.
